# Christ Church Cathedral Building Conditions and Issues Report

Project 21272

**Revision 0**

HERITAGE STANDING INC.

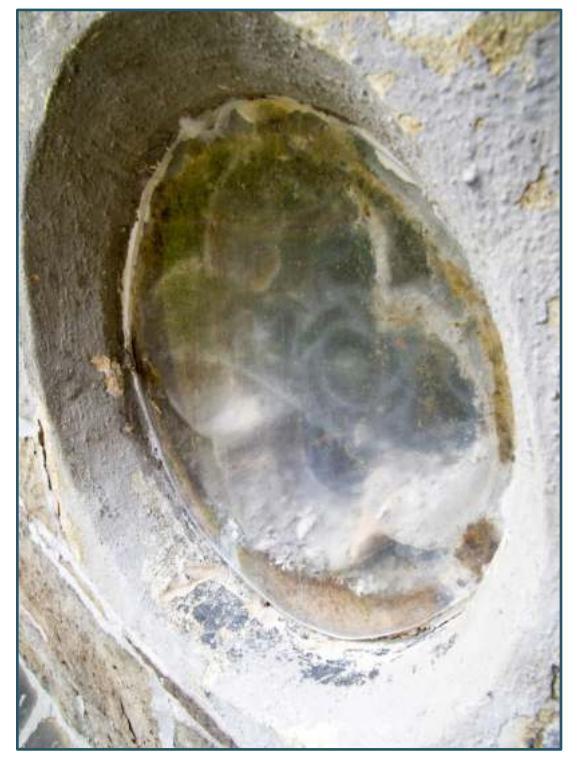
*Figure 3: Deterioration of stained glass window and frame in south vestibule entry*

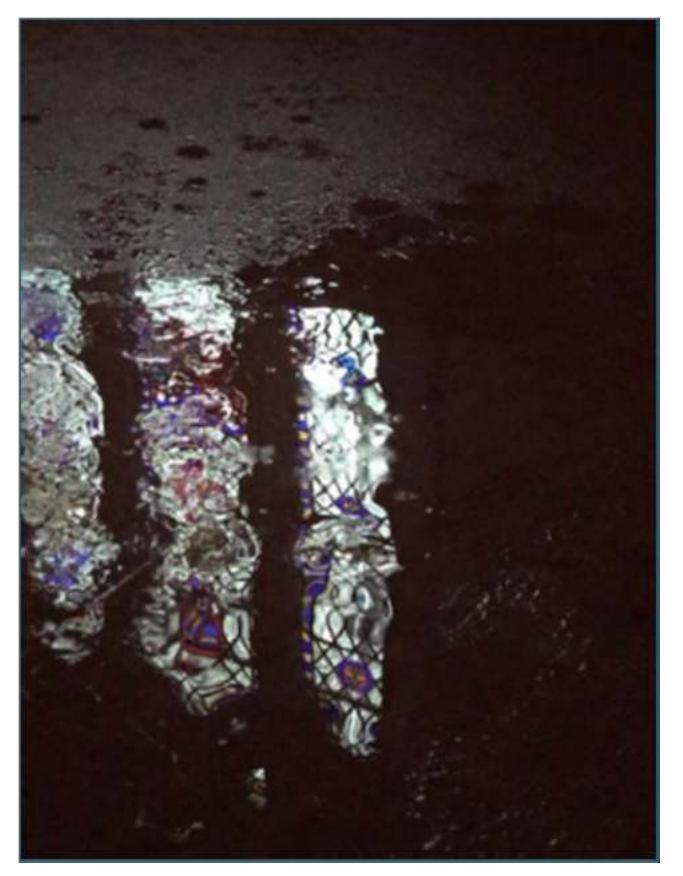
*Figure 10: Water splashing onto the southwest corner of the nave*

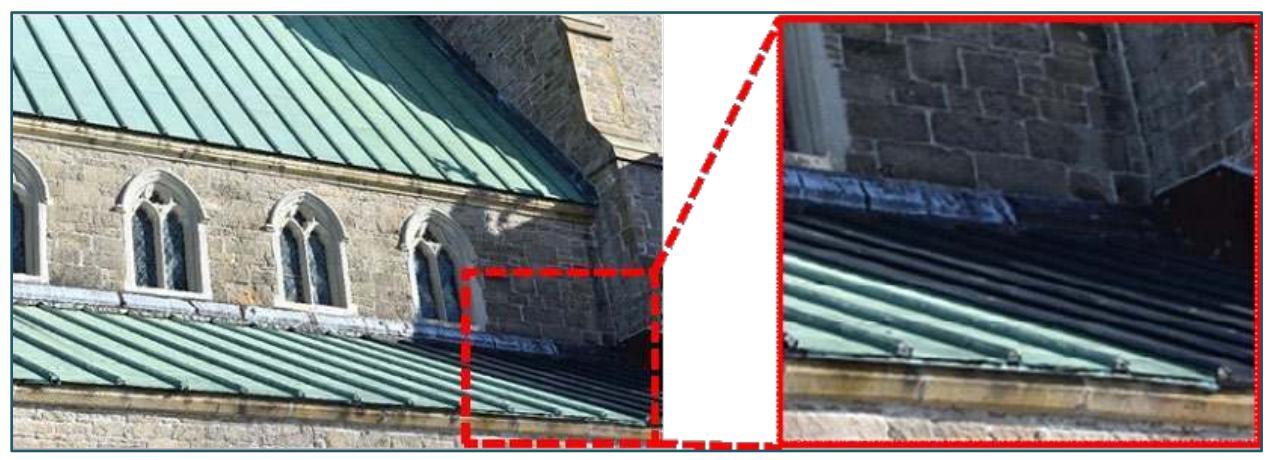
Replacement of the roof includes complete replacement of the lead flashing, which shows damage or is completely detached in numerous places, Figure 11.

Figure 11: Example of missing lead flashing on south clerestory

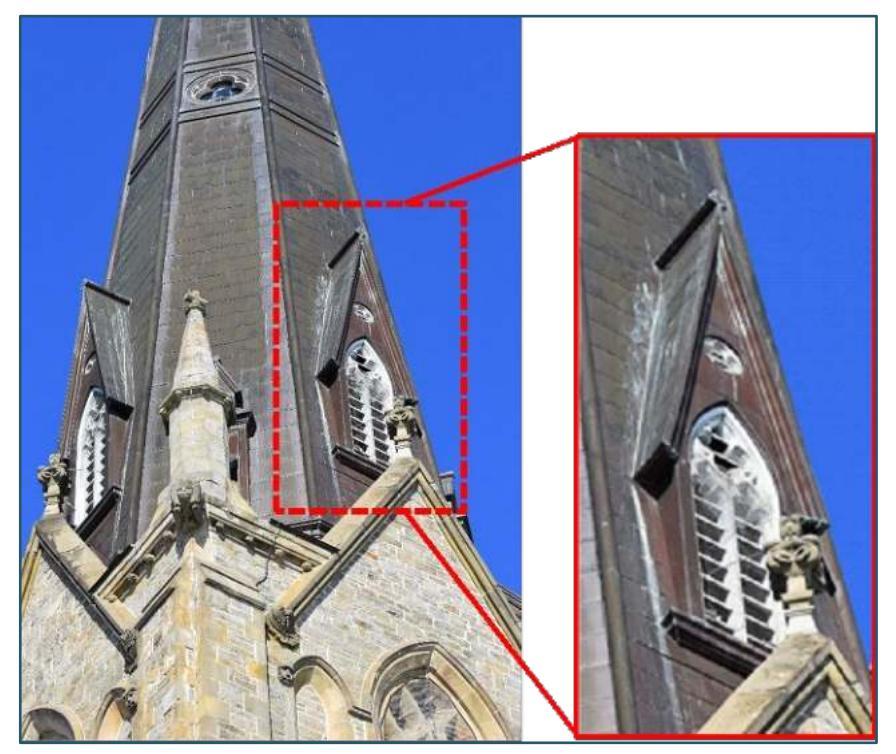
significantly detract from the mechanics of the louvres. A screen is missing from the west facing steeple louvre above the bell, shown in Figure 17.

*Figure 17: West facing louvre steeple window. Insert shows missing screen.*

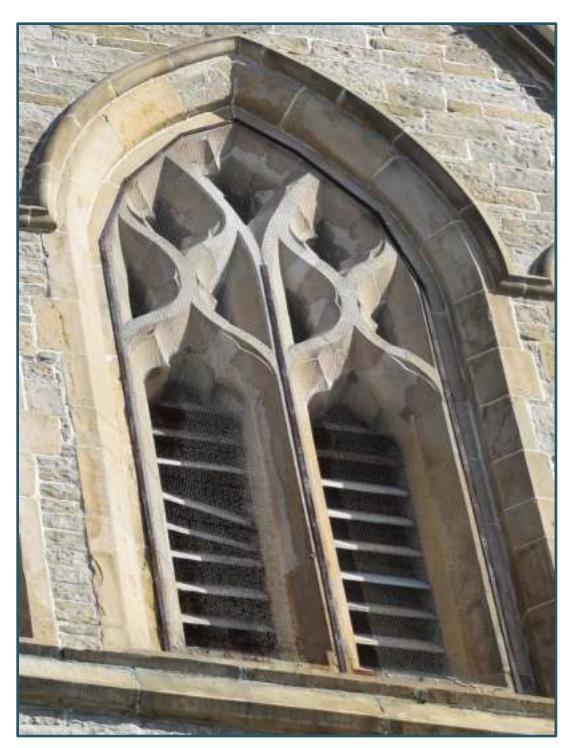
Figure 18: Broken louvre on south facing tower window

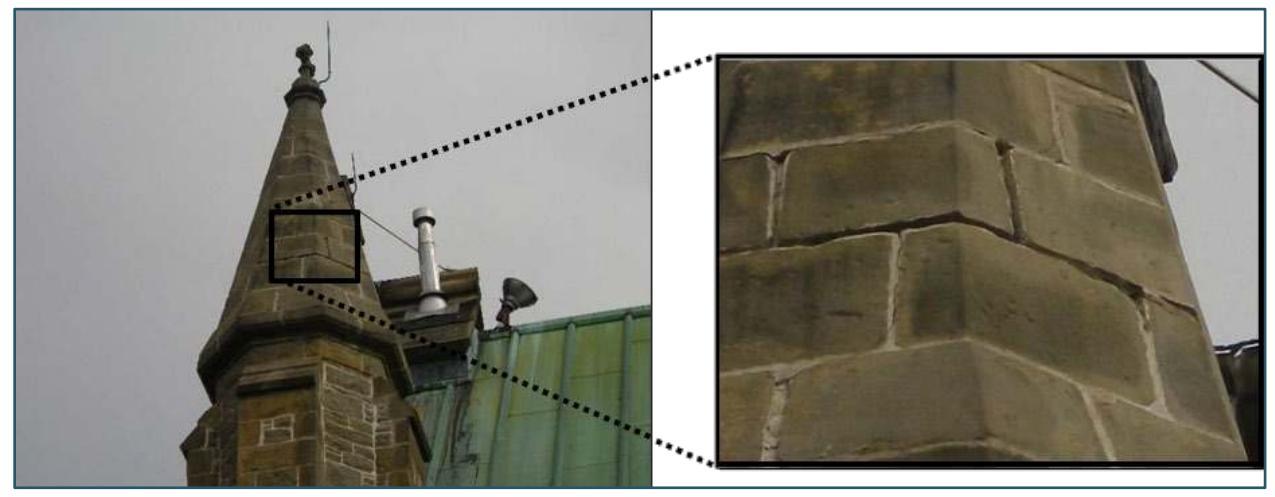
examination of the mortar in the SW pinnacle in 2015, shown in Figure 22, and in 2021, shown in Figure 23. The vertical cracking down the header joints in this pinnacle shows that the stones have begun to shift. This type of deterioration was seen at multiple pinnacles around the building during the 2021 evaluation.

Figure 22: Detail of SW pinnacle deterioration in 2015

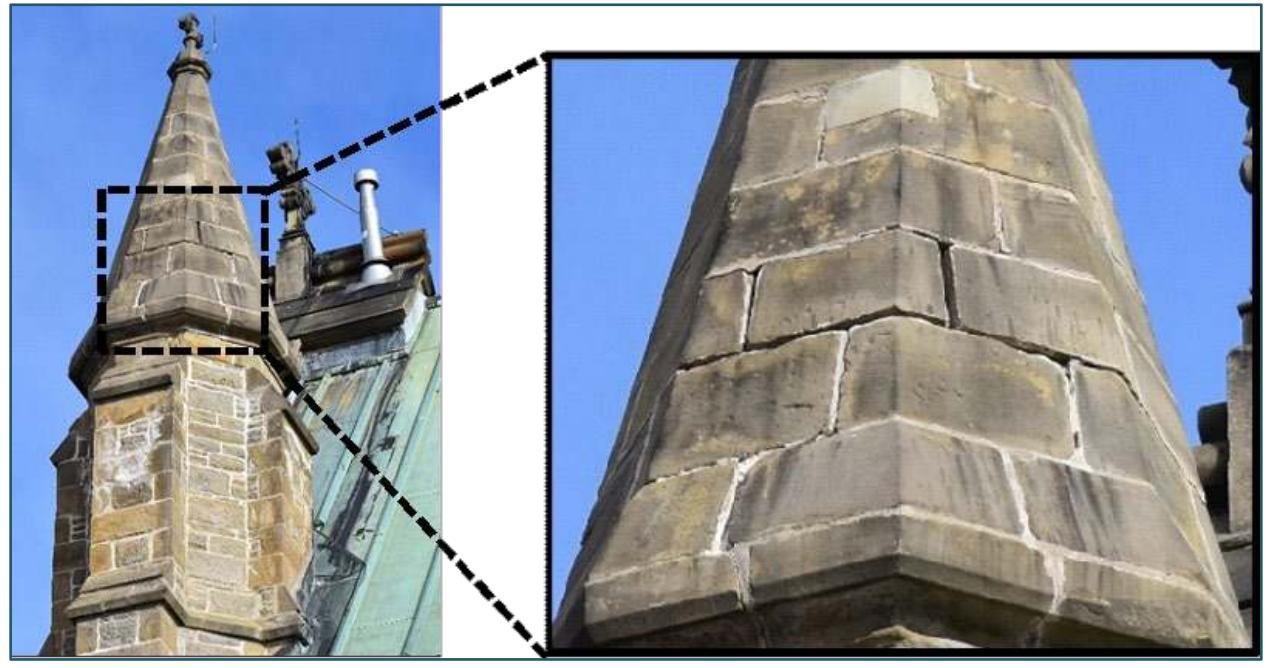
Figure 23: Detail of SW pinnacle deterioration in 2021

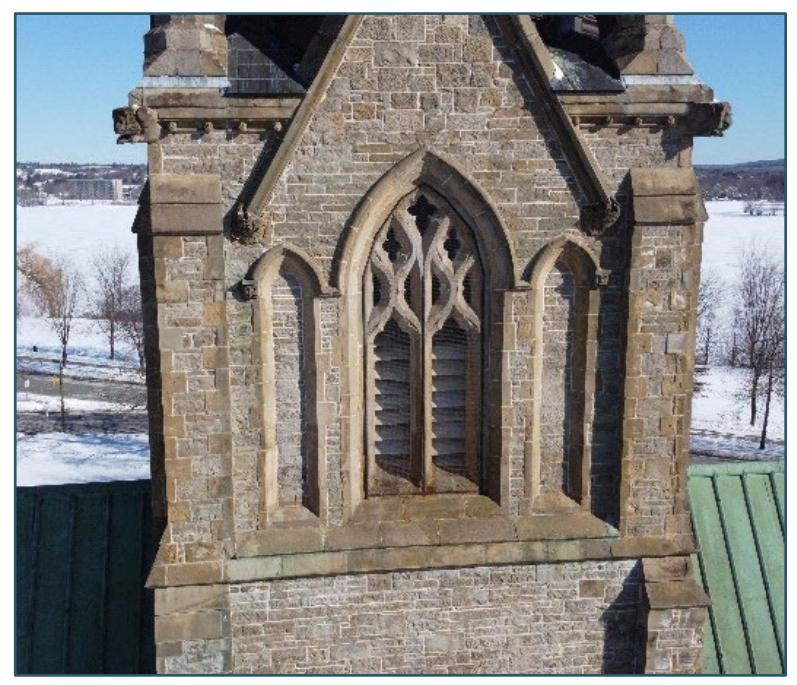
Figure 24: Exterior masonry of steeple, note deterioration of sandstone on right side of photograph

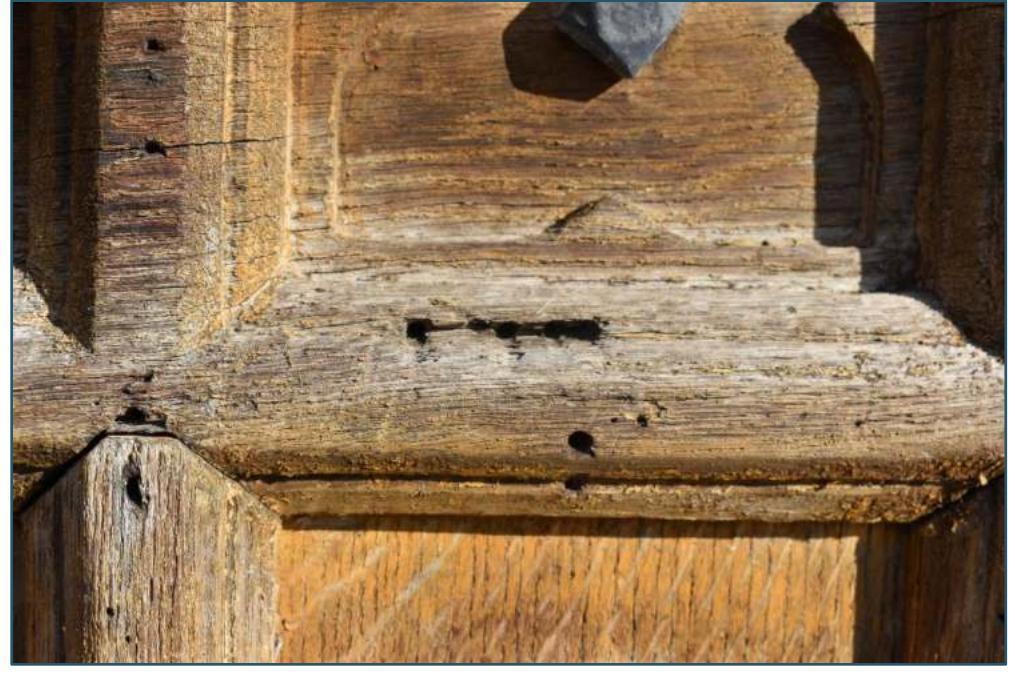
Figure 27: Example of poor condition of wooden door at main south entrance

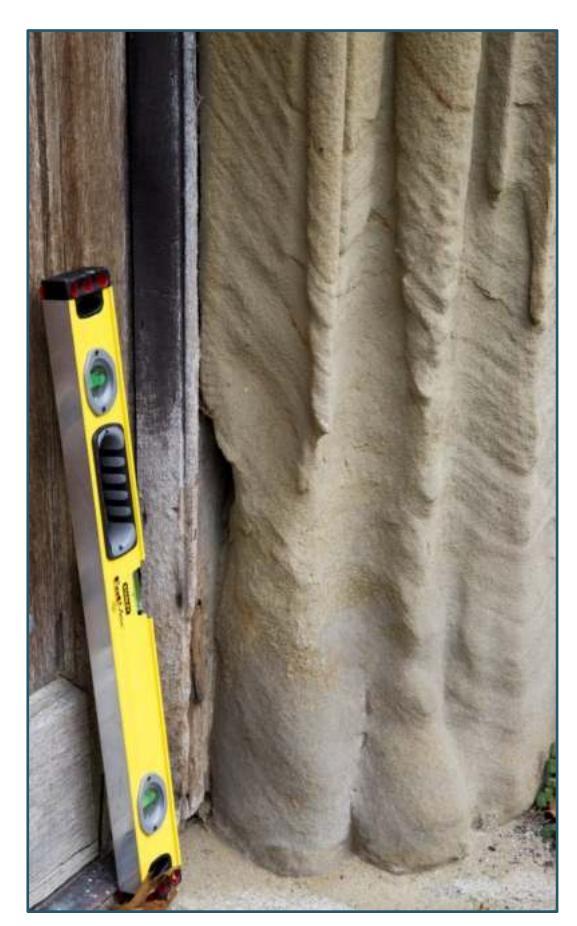
*Figure 28: Damage to sandstone framing the south main door*

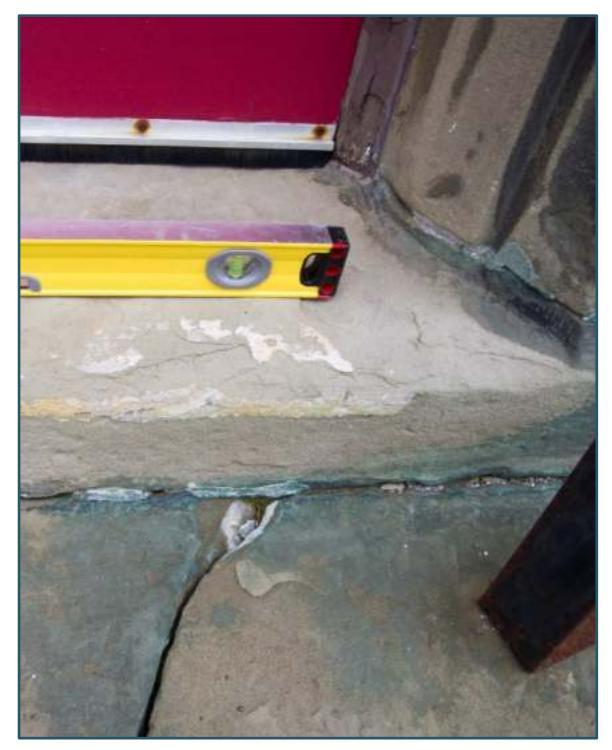
The sandstone sill, shown in Figure 33, and the base of the doorframe to the height of approximately 90 cm, shown in Figure 34 are decayed. Approximately 2.25 linear metres of carved sandstone will be needed to replace the decayed area of the frame and another 1.5 metres for the sill. Repair will eventually be needed but is not urgent.

*Figure 33: Sandstone sill damage on south vestry door*

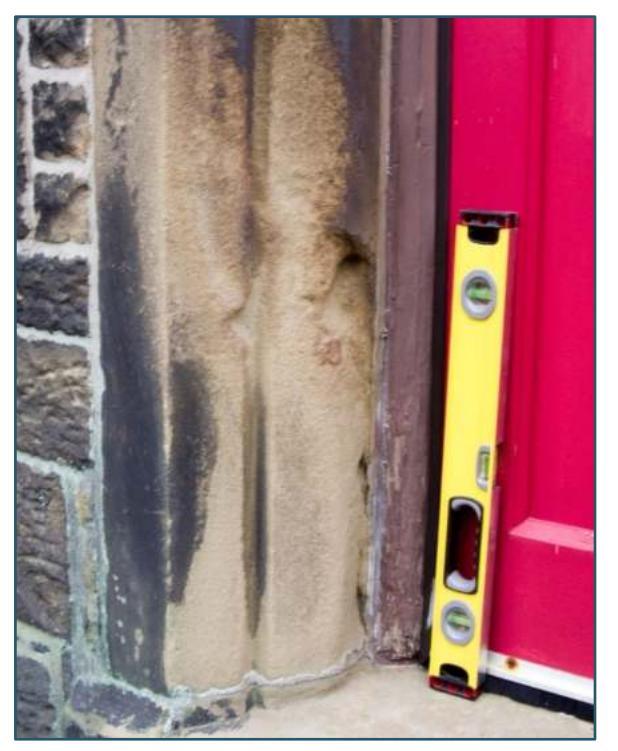
*Figure 34: Sandstone frame damage on south vestry door*

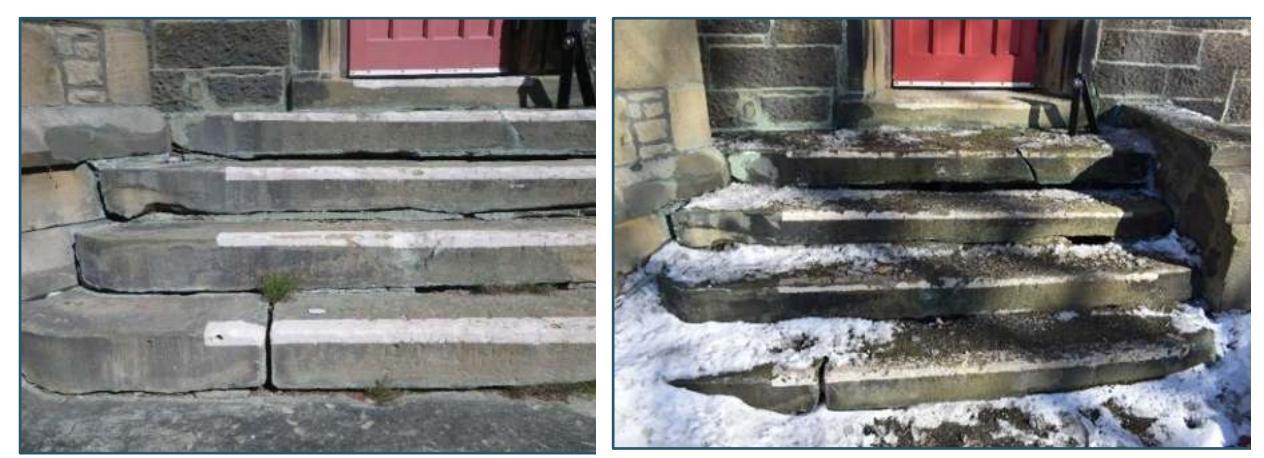
The south choir vestry stairs are in poor condition and rapidly continue to deteriorate (Figure 37 and Figure 38). They should be considered unsafe for use.

Figure 37: South vestry stairs 2015

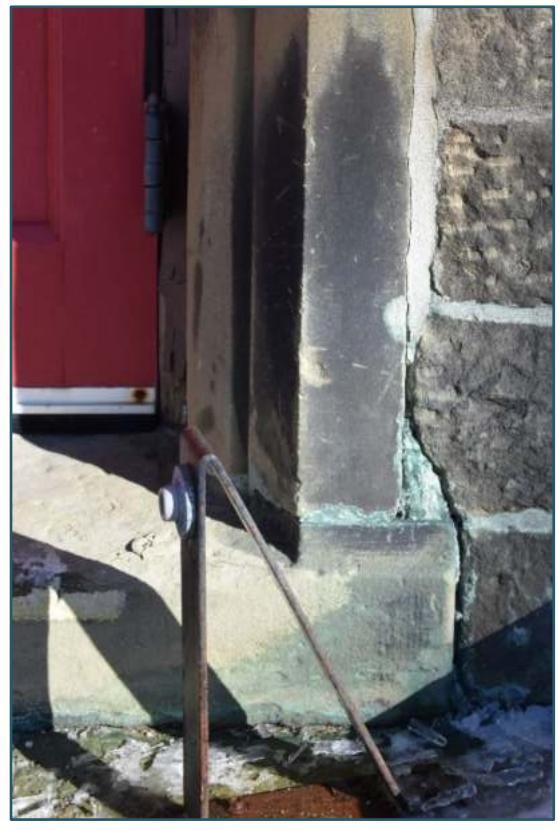
Figure 40: Failed repair to east of door

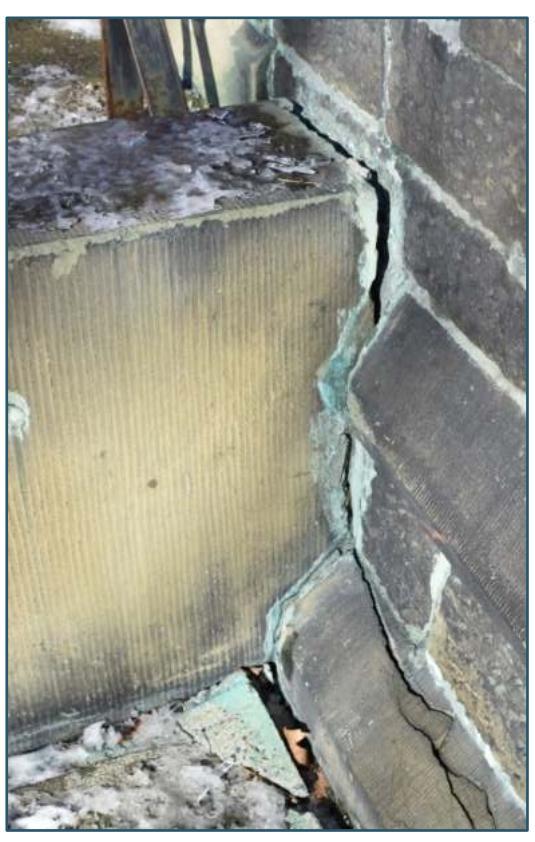
Figure 41: Failed repair to east of boundary wall

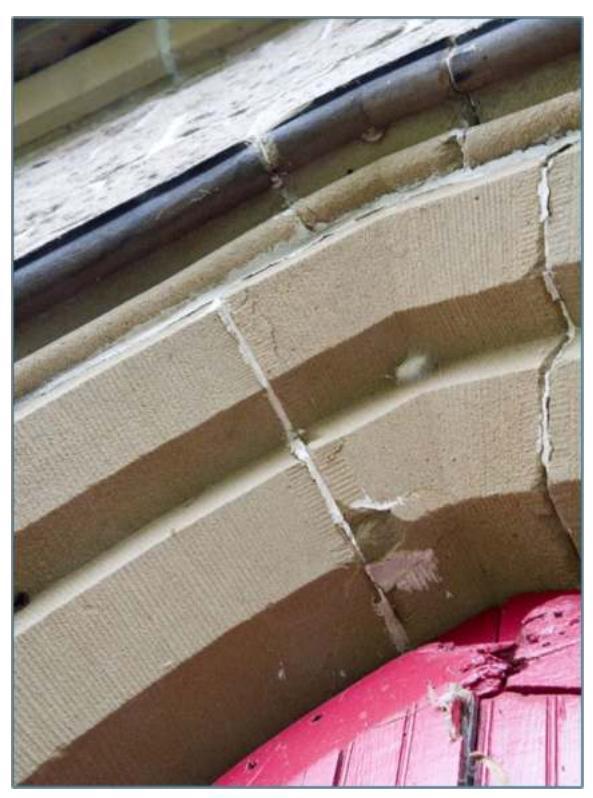
A crack is visible at top left of the arch of the sandstone door frame (Figure 42). Masonry repair is needed here and elsewhere on the door frame. The door itself is warped and does not sit in the door frame. At this time the door is not in general use.

*Figure 42: Top of north side door arch with visible crack along a 45 degree mortar joint at centre.*

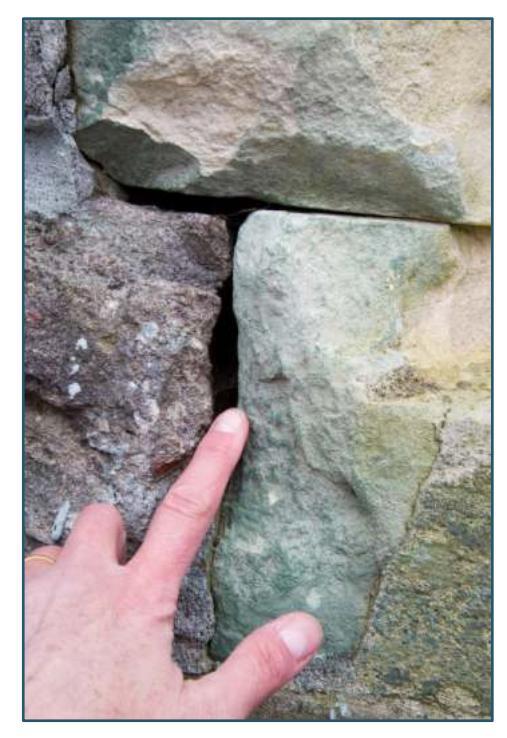
*Figure 43: Failed header joint and bedding joint, repairs to be treated under general masonry*

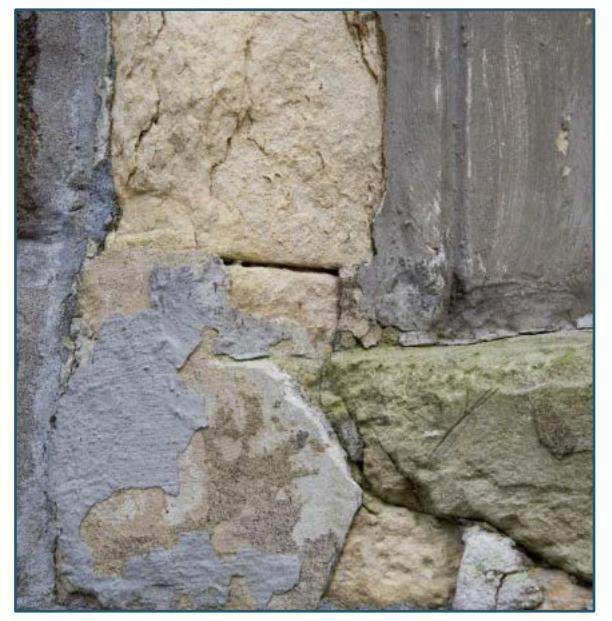
During construction of the Cathedral, a soft pale Caen Stone was imported from France to meet a specific aesthetic for the new building. This stone was found to not perform well in the New Brunswick climate. Multiple repairs were done before the Cathedral began replacing the stone with Indiana Limestone during the 1990s repairs. The replacement comprised only a small number of windows, and those where the Caen Stone remains are typically deteriorated and failing. HSI has identified 39 windows in which the stone frames and or tracery are still the original Caen Stone (Figure 45). This stone continues to decay over time, as for example seen in Figure 44.

*Figure 44: Decayed Caen Stone on Window 48. Note the failed cement overlay patch at lower left.*

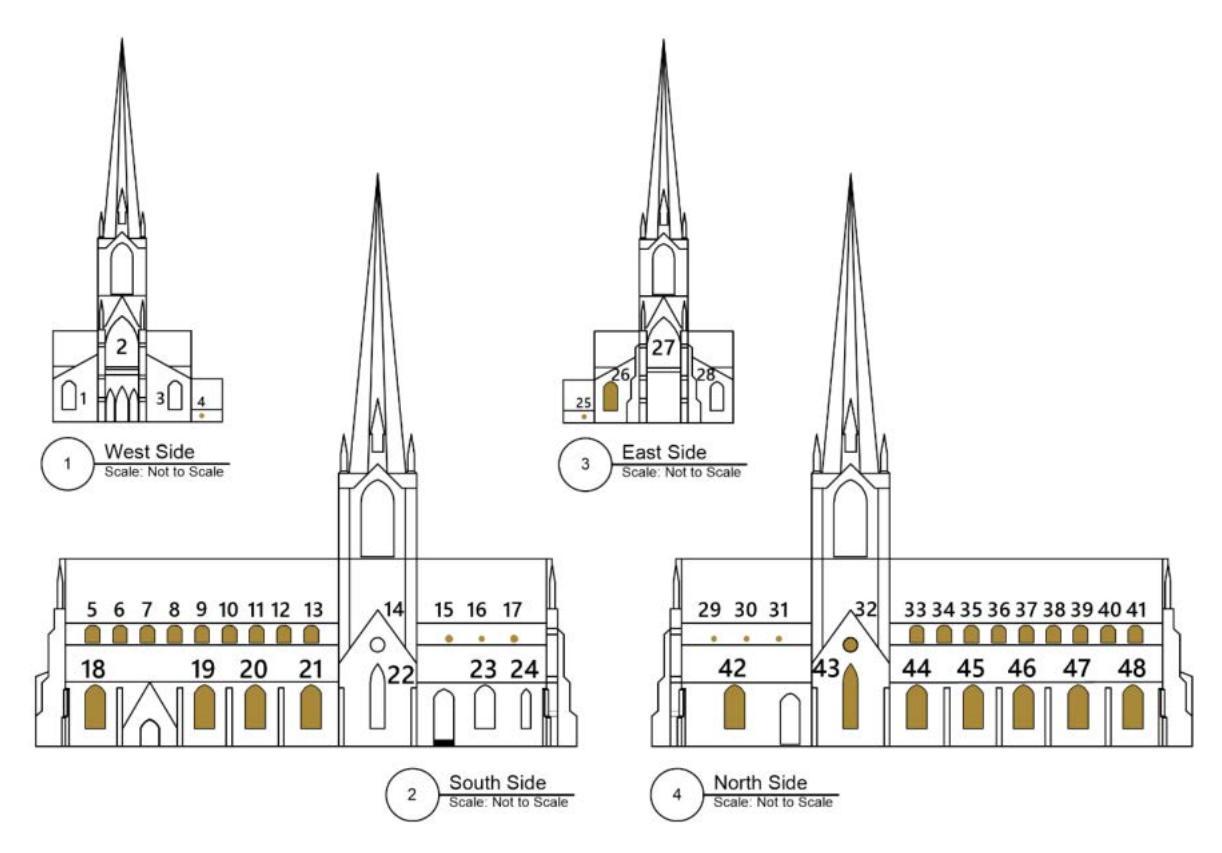
*Figure 45: Locations where original Caen Stone used in the tracery and frames require replacement. Note east and west window tracery have all been replaced.*

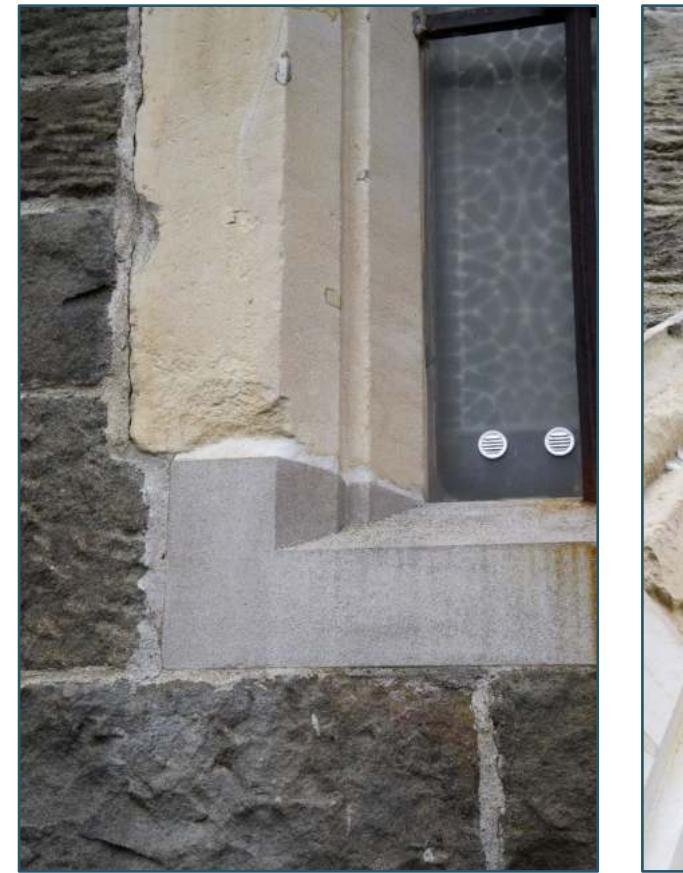
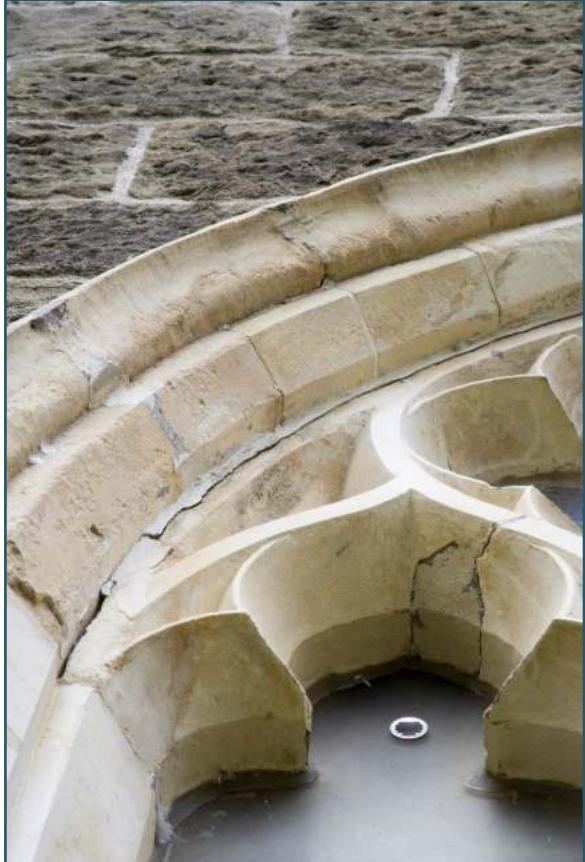
*Figure 46: Window 26 frame damage, note the more Figure 47: Window 26, tracery damage durable Indiana Stone sill*

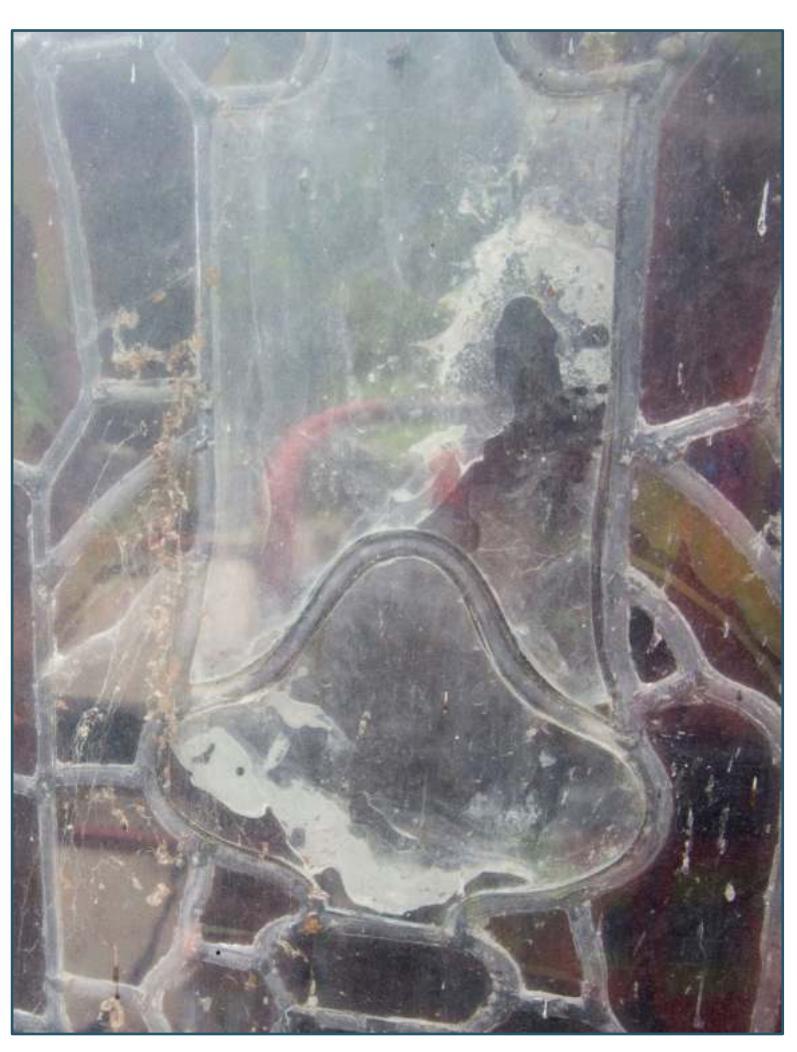
Figure 54: A glazing overlay repair that has separated from the original stained glass on Window 2, the main west window. Note the presence of debris or biological material between the stained glass and repair layers.

Windows should be cleaned at the same time to improve lighting in the sanctuary. As much of the repair work as possible should be done in-situ.

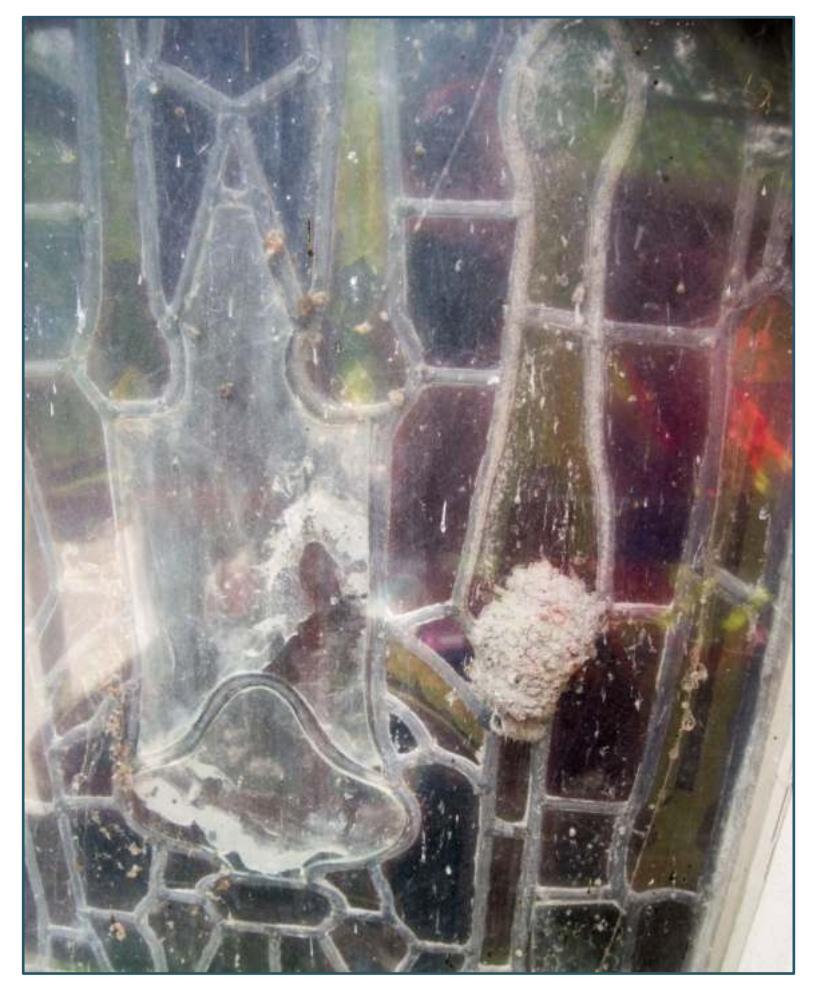
Figure 55: Larger view of Figure 51 above. Insect and arachnid debris on stained glass and exterior protective glazing on Window 2. Note the wasp nest on the right is adjacent to a failing stained glass patch that appears to contain debris or biological growth.

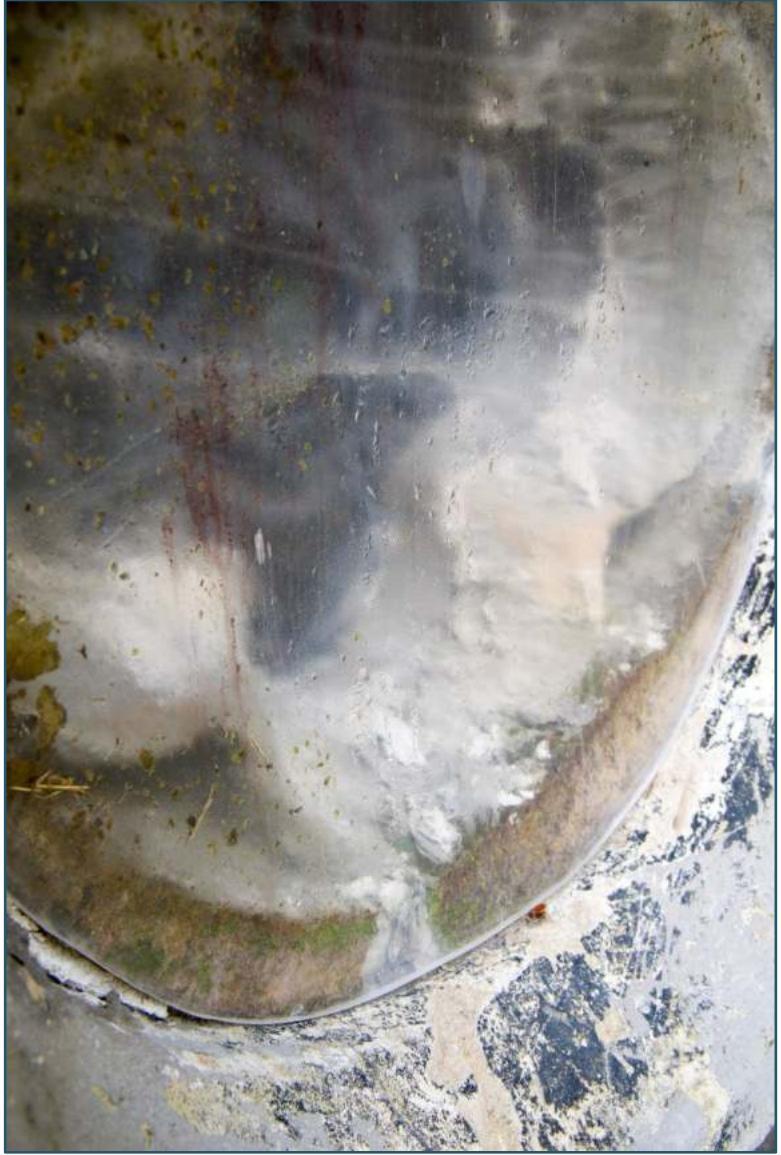
*Figure 56: Moss, fungi, animal, and moisture damage in Window 25. Note the lack of sealants at the edge of the EPG.*

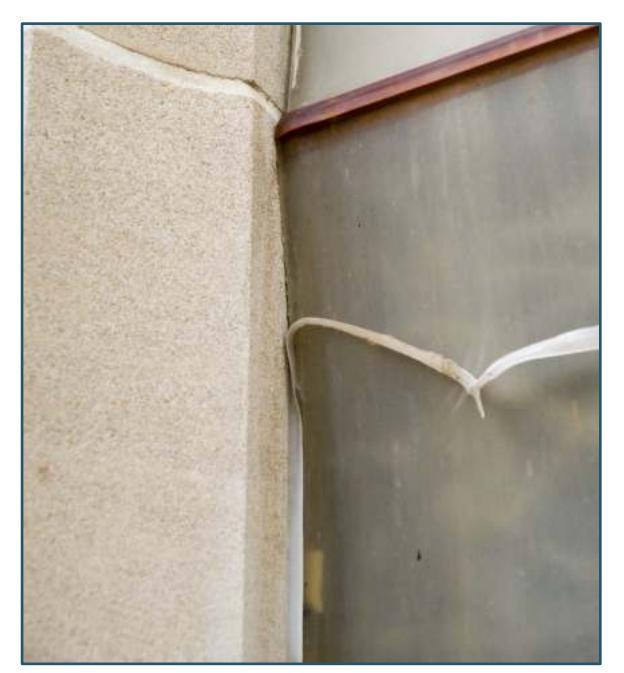
*Figure 57: failed vertical and horizontal sealant between EPG and masonry*

Damaged sealants (Figure 57) should be repaired and/or replaced and areas that were originally left unsealed (Figure 58) should be closed off so that biological entities and moisture cannot enter and create damage or grime.

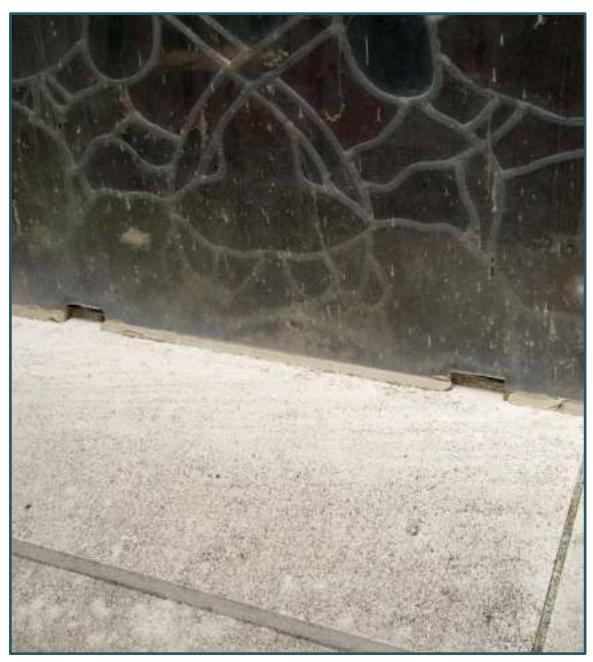
*Figure 58: simple original vents lacking screens or louvres*

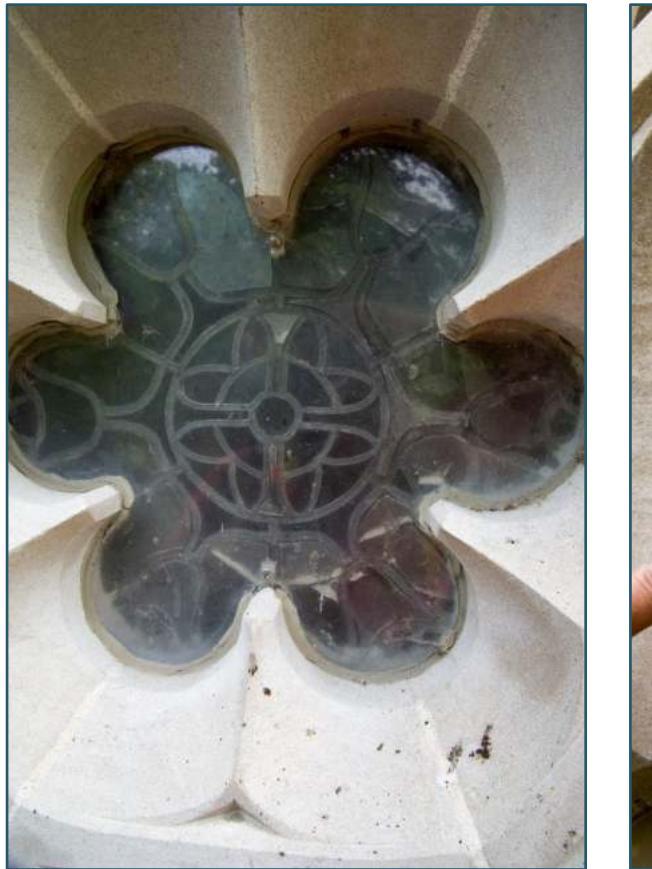
The tracery has not been vented with gridded vents. In some cases, it has not been vented at all (Figure 59). In other places, gaps have been left at the top likely to enable airflow to cool the glass (Figure 60). These have enabled insect habitation as well.

*Figure 59: Unvented tracery. Note that it has required repairs in the past (areas of frosted glass overlay) possibly due to excessive heat buildup.*

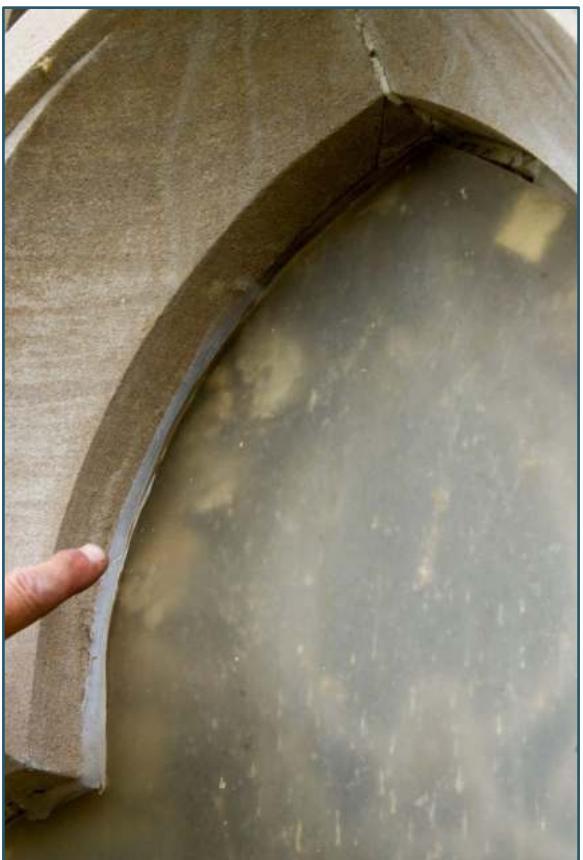
*Figure 60: original simple vents left at top of tracery. Note the wasp nests (light shapes at end of finger) and debris between the layers of glazing.*

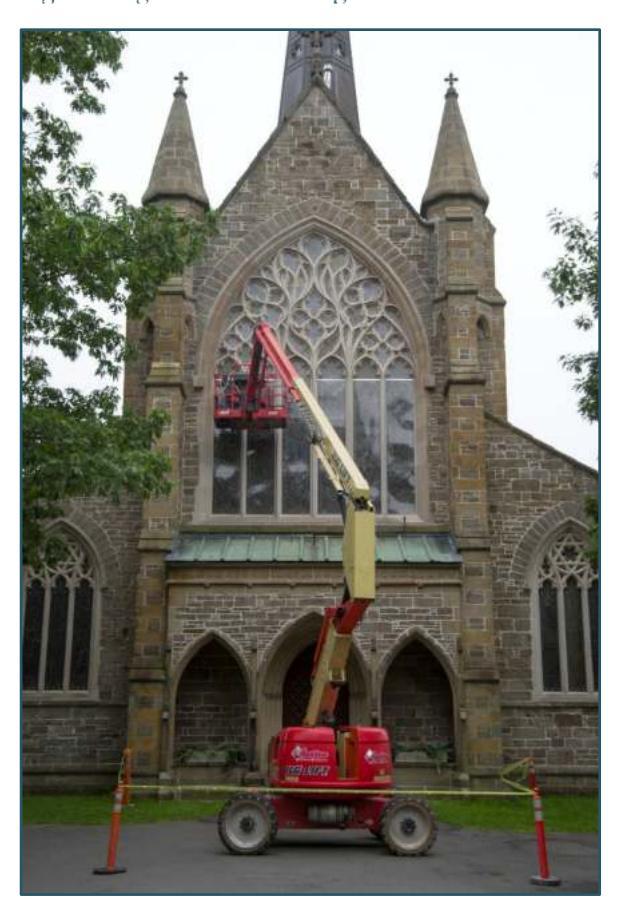
*Figure 61: Warping visible in the reflections on the EPG on Window 2*

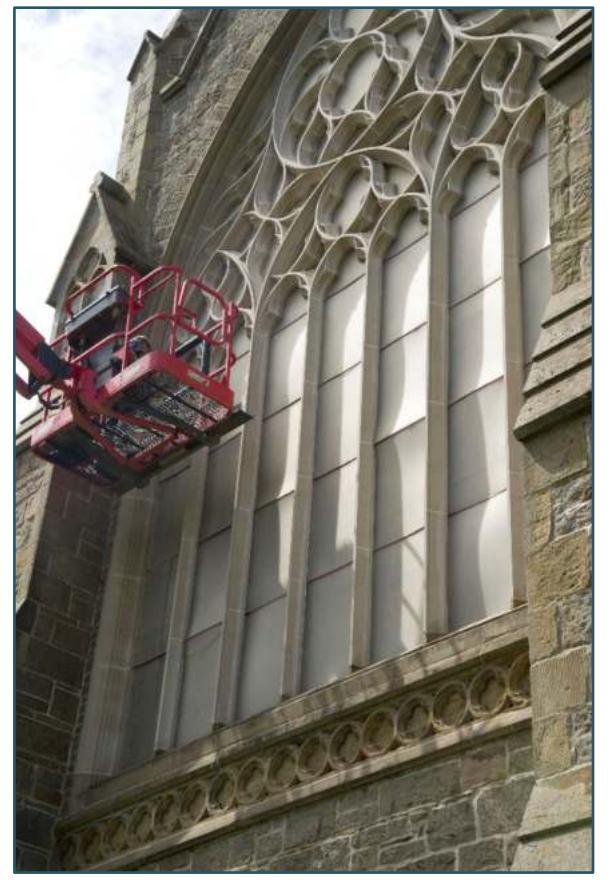
Figure 62: warping visible in the shadows on the EPG on Window 27. Note also that the EPG is so hazed that it is almost impossible to make out the stained glass behind it.

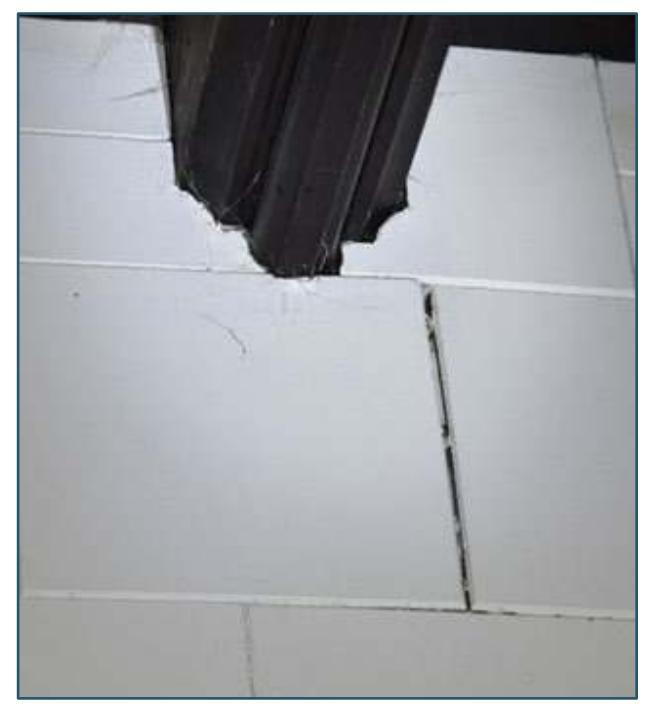
Figure 64: Crack on interior sacristy wall

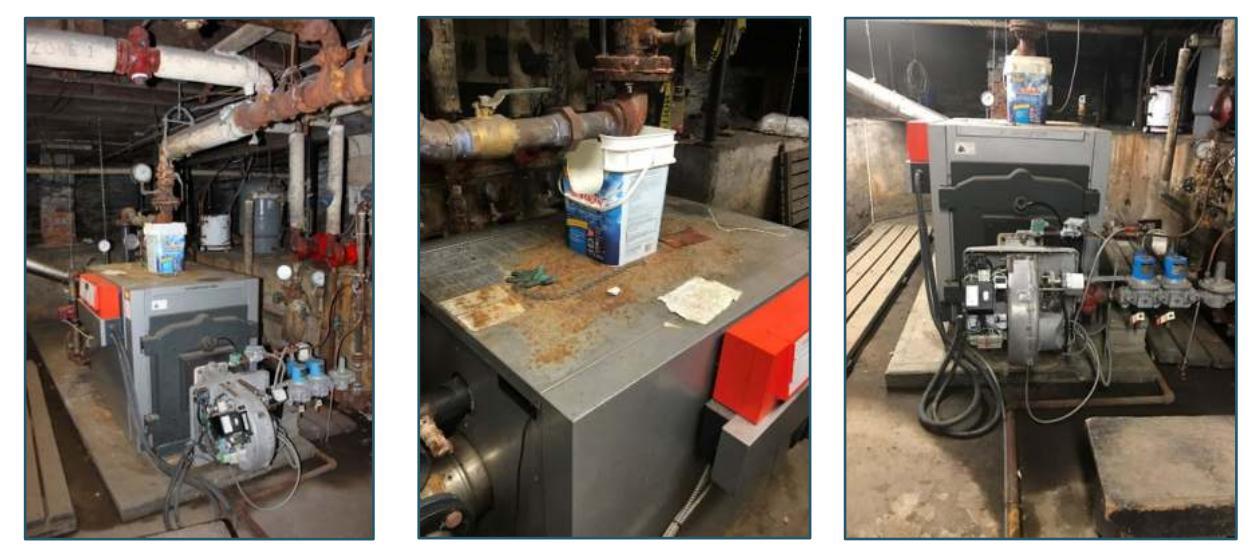
Figure 65: Boiler and burner (left), top of boiler housing showing rust (centre), exposed burner (right)

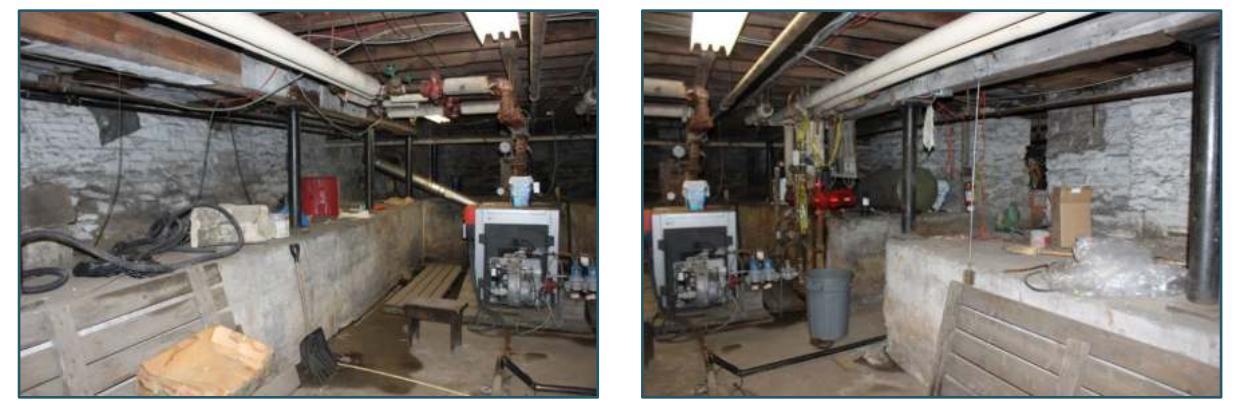
Figure 76: Debris

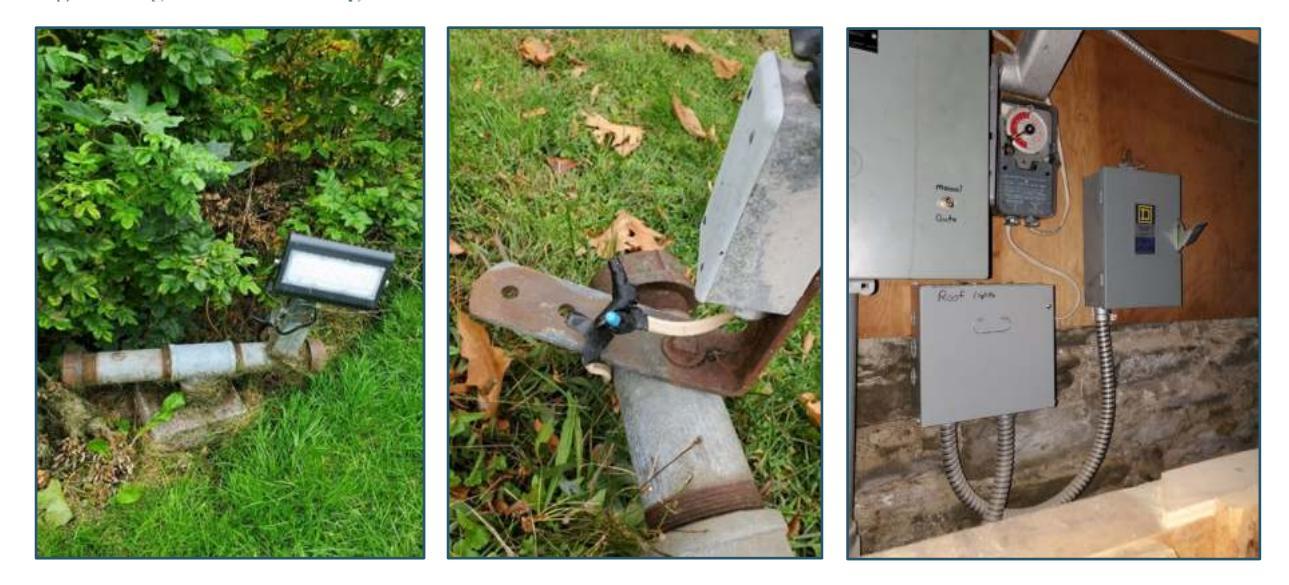
*Figure 97: Exterior flood light taped connection*

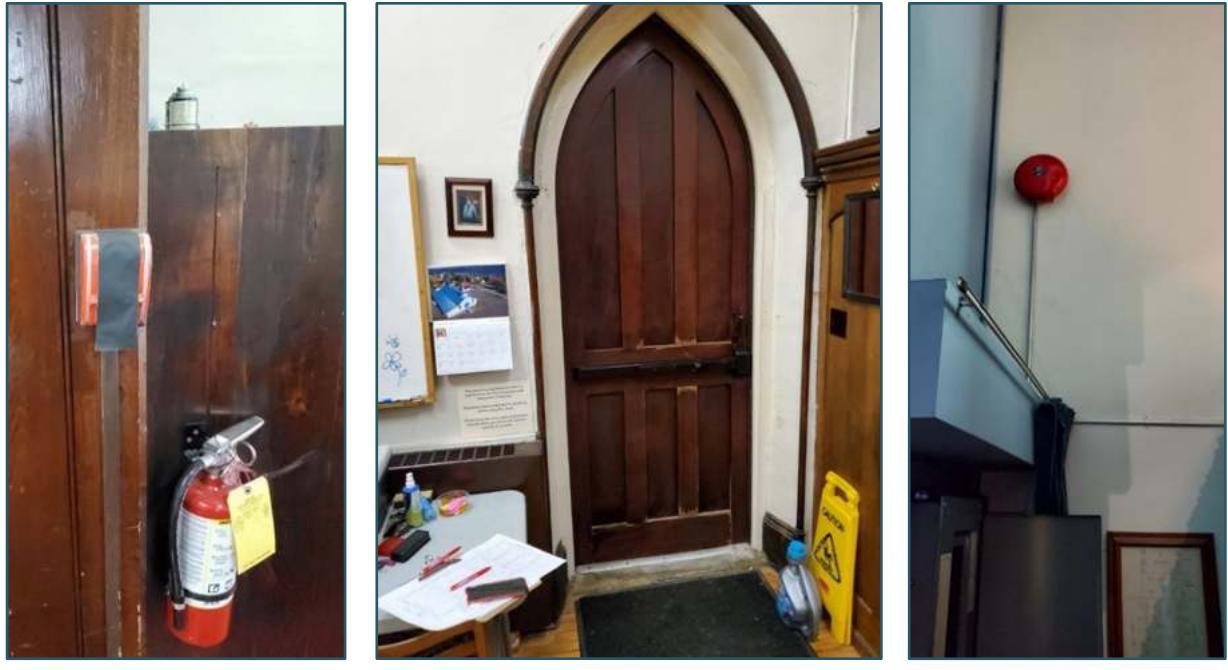
Figure 101: Taped pull station
