# Christ Church Cathedral Building Conditions and Issues Report

Project 21272

**Revision 0**

HERITAGE STANDING INC.

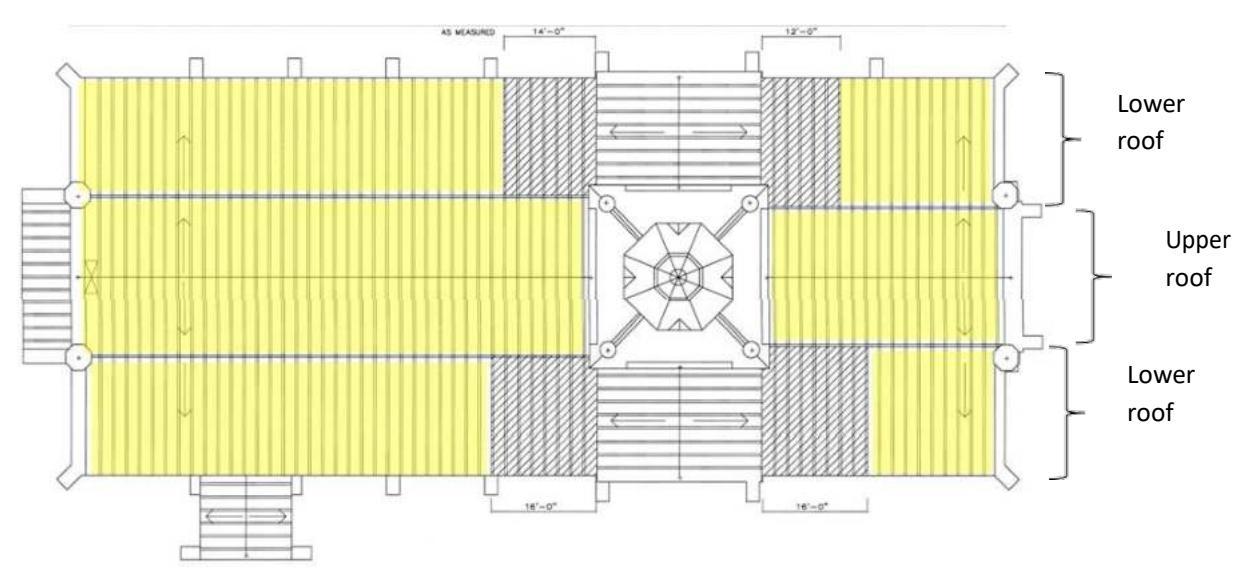
Currently the entirety of the copper roof of Christ Church Cathedral requires replacement. This report breaks down the copper roofing into two distinct areas, as shown in Figure 9, because of the different nature of their problems. The first section is the main lower section of the Cathedral (primarily the nave), and the second is the steeple and roofing in the area of the chancel. Design for both should be combined, even if the project is phased.

*Figure 9: Cathedral roof sections: yellow areas date from ca.1911 or before, grey shaded areas and steeple date from the 1990s.*

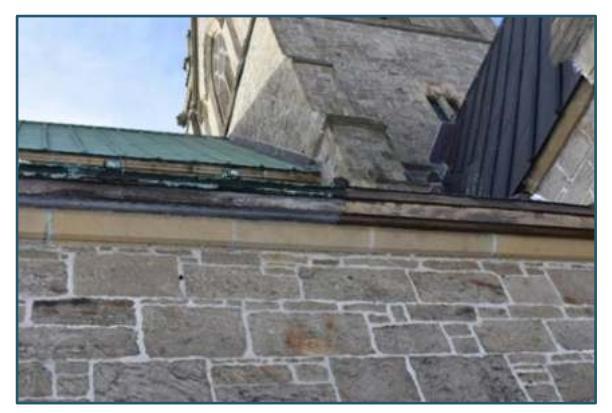
The northeast and southeast lower roof facia boards are decaying because they are missing the protective copper cladding that should be present, as shown in Figure 12 and Figure 13. The wooden facia boards should be inspected, repaired or replaced where damaged, then covered with copper cladding.

*Figure 12: Missing copper cladding on facia along the northeast lower roof*

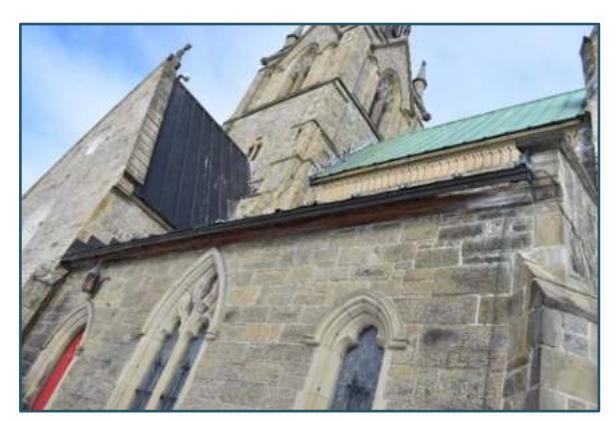
*Figure 13: Missing copper cladding on facia along the southeast lower roof*

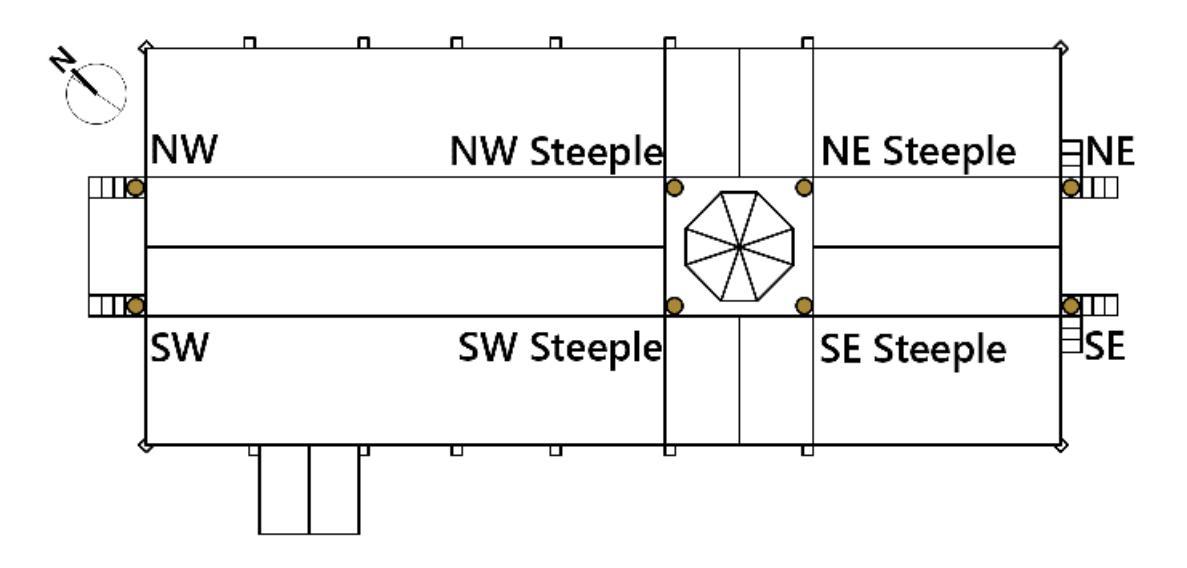
Damage to pinnacles is particularly concerning because the function of pinnacles in stone masonry was originally to provide a greater dead load at a given point to weigh down forces that may otherwise push outwards or overturn a given section. It is suspected that these pinnacles are functional and not purely aesthetic. The location of pinnacles is shown in Figure 19.

Figure 19: Location of Christ Church Cathedral pinnacles with pinnacles highlighted in gold

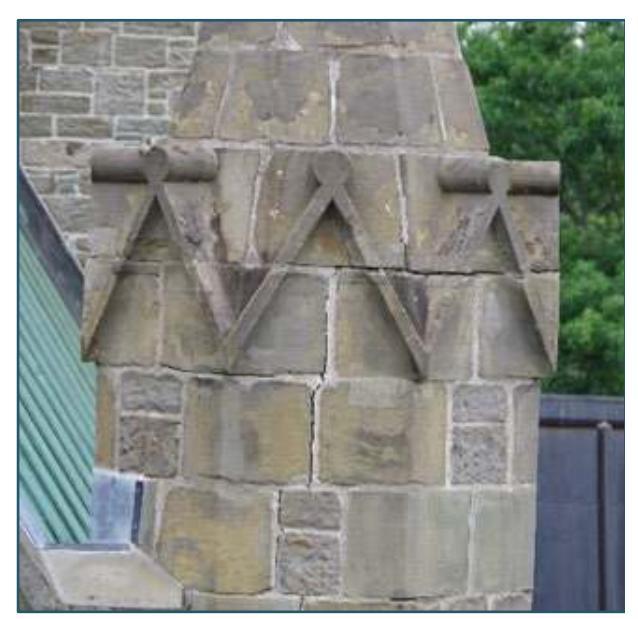
As described in the HSI 2020-08-04 Roof Repair Notes letter, the masonry of the steeple and pinnacles shows debonding failure of the masonry joints in many locations and instability consistent with incompatibility of prior repair materials, shown in Figure 20. There are also instances of poorly executed repairs to the stonework, shown in

Figure 20: Failed mortar joints in NE pinnacle

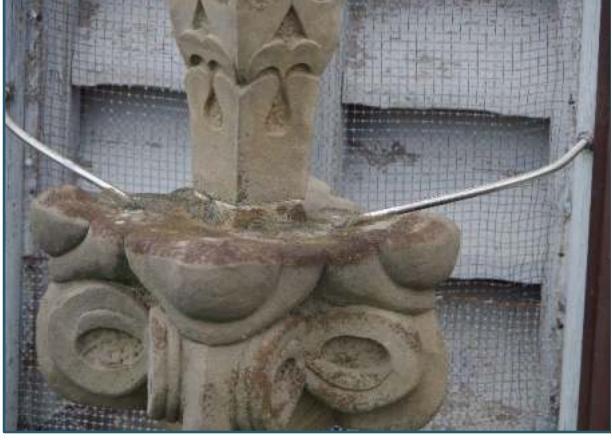
Figure 21: Masonry element with stainless steel threaded rod inserted into wood louver and epoxied to the top of stone

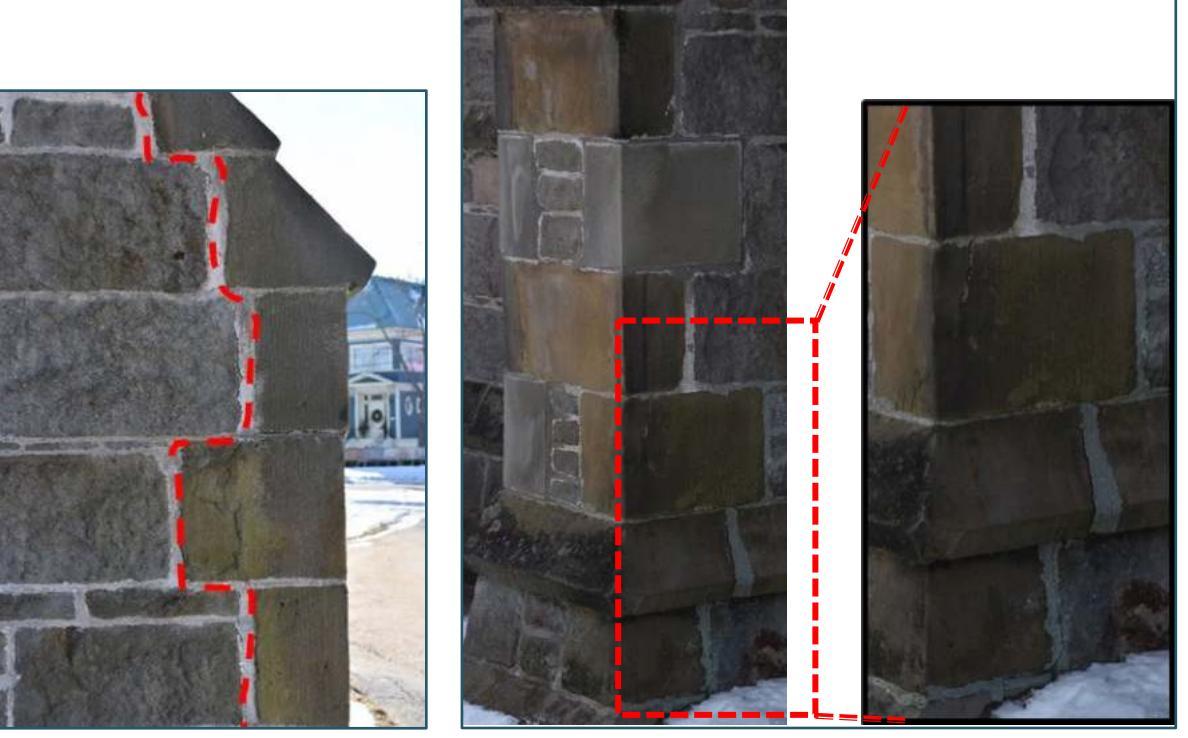
As documented in the 2021 Update to the 2015 Christ Church Cathedral Condition Assessment, most of the buttresses have vertical cracking between the outer most stones and the main buttress (Figure 25 and Figure 26), causing stones to be pushed away from the Cathedral. The deterioration has become more evident since the original 2015 Condition Assessment. Cracking around the buttresses suggests either overloading of the buttress, failure of the mortar, or a combination of the two. The repair design will likely need to consider the use of different mortars in different regions of the building to get best performance. Other simple strengthening measures can be included as part of the repair design for the buttresses, such as using stainless steel helical ties in the joint beds grouted to better engage the wall interior to the stone. Detailed design will be required for the intervention.

*Figure 25: Southwest corner buttress*

*Figure 26: Northwest buttress*

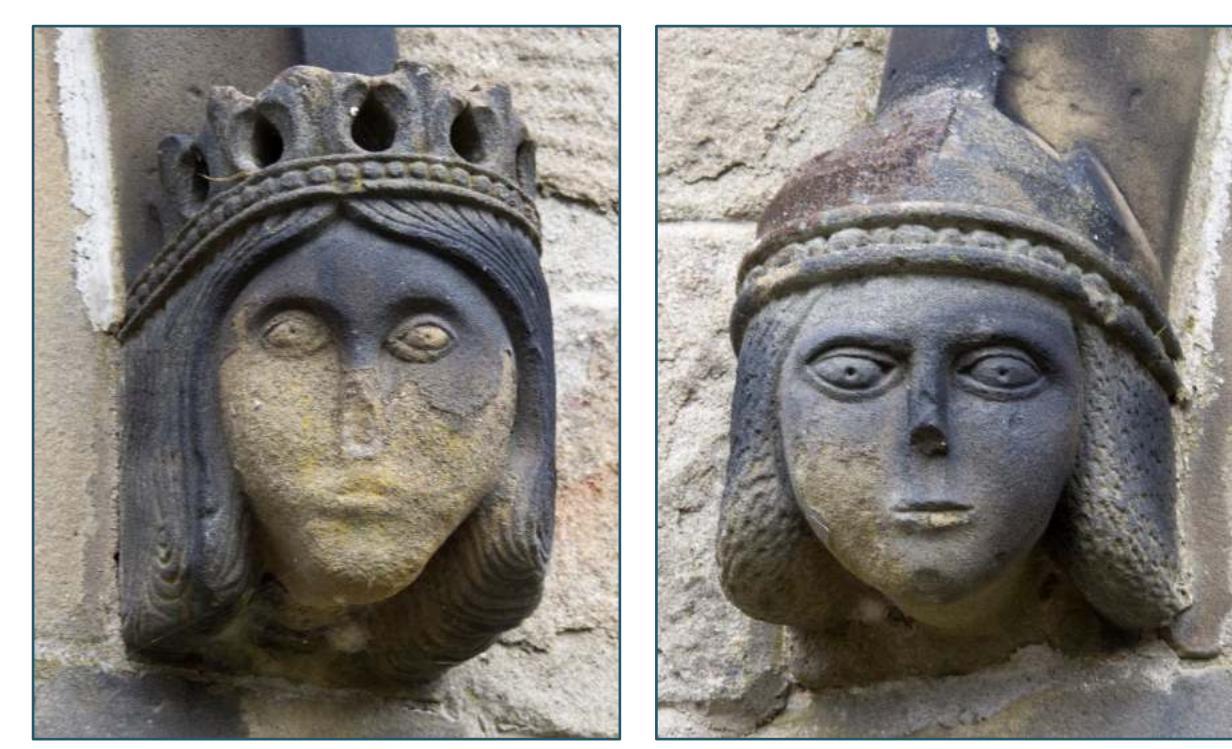
significantly, Figure 29. The face on the west, Figure 30, is in much better condition with only minor weathering.

*Figure 29: East figure at main south entrance*

Figure 30: West figure at main south entrance

If a stone carver is engaged, the condition of other carvings could be reviewed for potential necessary repairs. Collaboration with such highly skilled artisans in planning stages can provide great benefit to creating successful projects.

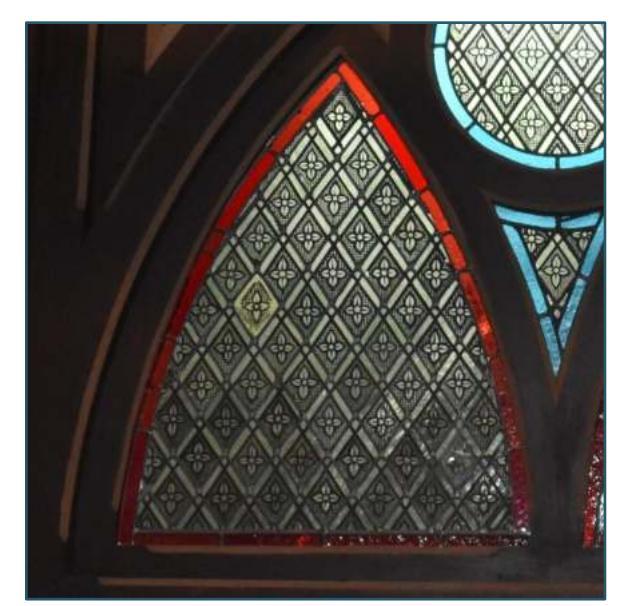
The glass of the inner door, Figure 31, has been damaged in multiple areas as described in the 2021 HSI Update of the 2015 Condition Assessment Report. Various panes have been broken by impacts and there has been movement withing the frame. The 2012 *Standards and Guidelines for the Preservation of Stained (and Leaded) Glass Windows* by the Stained Glass Association of America (SGAA) describes the production and preservation of this type of stenciled glass windows, Figure 32.

*Figure 31: Detail of inner glass doors of main south entrance*

Because they were cheap (for their purpose), mass produced windows, intended as a placeholder until stained glass could be installed, stenciled glass windows are generally made of very thin, poorly fired glass. This glass is fragile, prone to fading patterns, and difficult to match when broken. It can be challenging and expensive to repair or replace broken panes. The repair of these windows should be included in the stained glass conservator's evaluation of window damage.

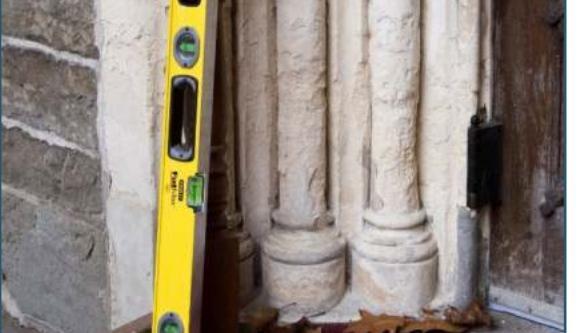
The sandstone carving at the base of the main door frame exhibits damage to a height of approximately 70cm from weathering and/or mechanical damage such as shoveling and salting (Figure 35 and Figure 36). The replacement of the bottom two sections of the door frame will be required at some point.

Figure 35: Damage to left side of main door frame

The sandstone framing the exterior doors, including cut and sculpted stone, should be repaired or replaced as required

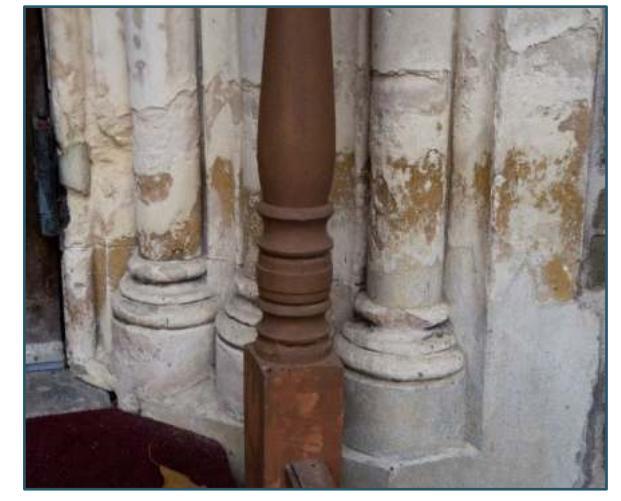
Figure 36: Damage to right side of main door frame

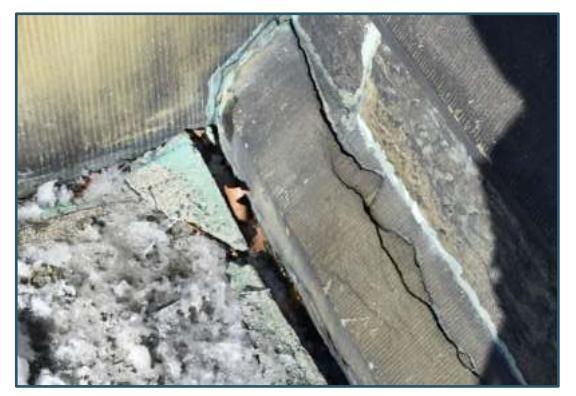
In addition to repairs to the stairs, there is also damage occurring to the church around the building (Figure 39, Figure 40, and Figure 41). It would be prudent to address this masonry damage at the same time as the stairs are being repaired.

*Figure 39: Cracking on adjacent wall to the east of the bounding wall*

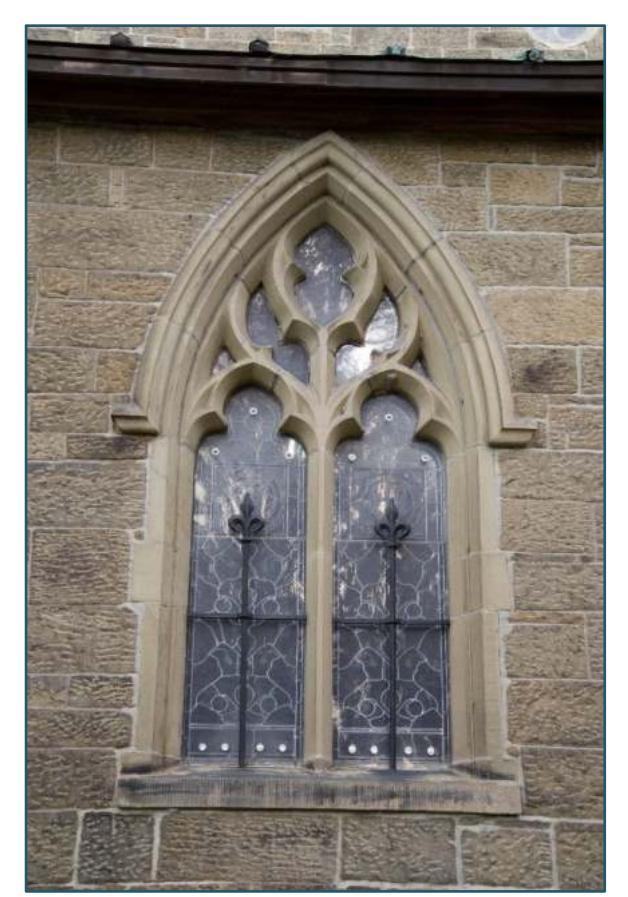
Figure 48: Window 23

Windows 23 and 24 (Figure 48 and Figure 49) and the four tower windows, not pictured in the schematic illustration of Figure 45, appear to be older but carved of a more durable stone than the Caen Stone. These stone frames do not need replacement at this time, and in contrast with the Caen Stone appear to underscore its long term problems.

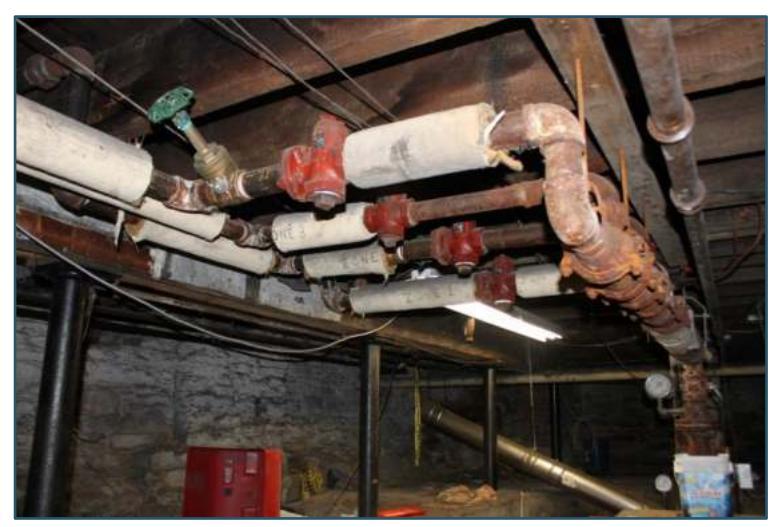
The 'Flo-Trol' zone control valves (Figure 67) are located at the supply header and used for preventing heating or overheating of zones due to gravity flow in hydronic heating systems and will permit summer-winter operations. These valves appear functional and there is no concern regarding the present system configuration.

Figure 67: Supply header, Flo-Trol valves

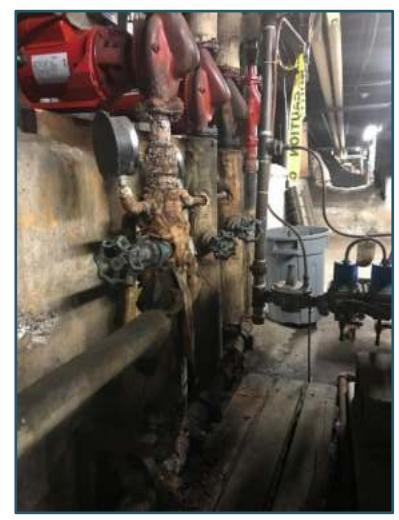
The zone circulating pumps are 1 ½ horsepower, 1½ inch vertical in-line pumps (Figure 68, Figure 69, and Figure 71). These types of heating appliances are standard for hydronic systems, they are reported as functioning. There is a minor concern regarding age of these pumps. The casings show corrosion and discolouration which indicates moisture, possible leaking, and potential operation outside their temperature range in the past (Figure 70). This observed damage will eventually lead to failure necessitating repairs and/or replacement, however, as the pumps are reported to be functioning, the concern is only minor.

*Figure 68: Return header, circulating pump*

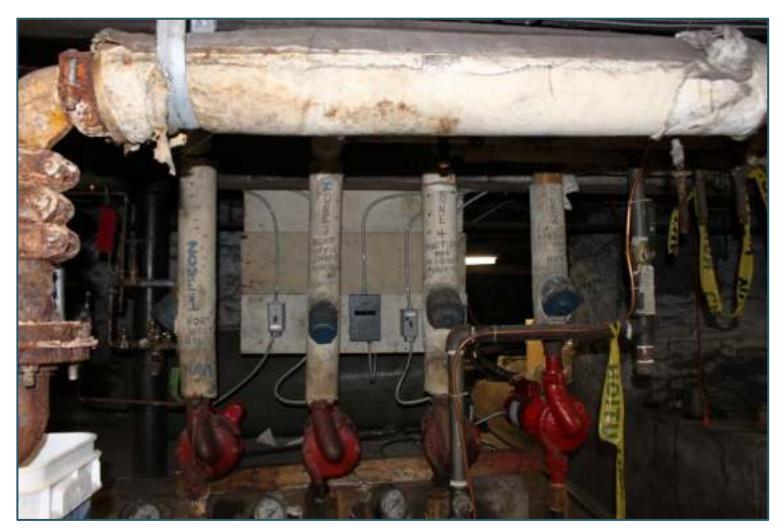
Figure 69: Circulating pumps, zone identification

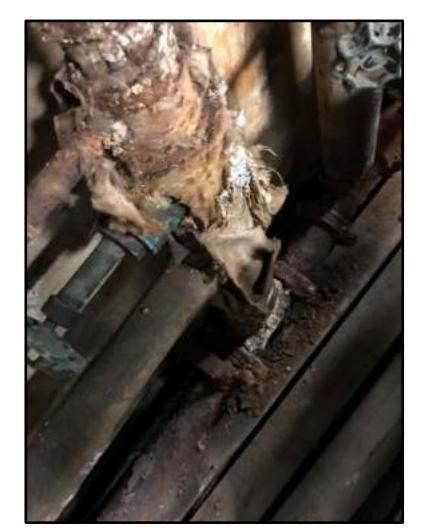
Figure 70: Insulation damage

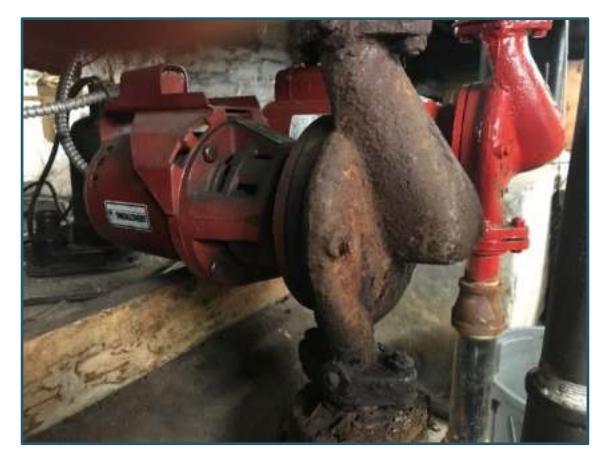
Figure 71: circulating pumps 1 (left) and 4 (right)

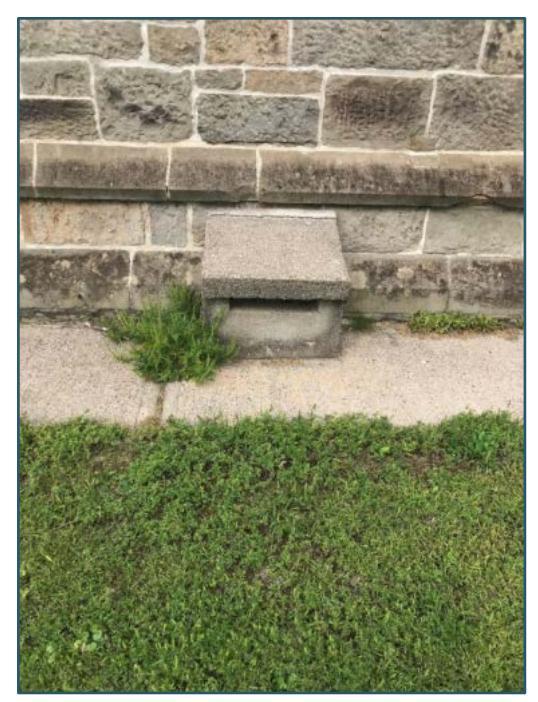
Christ Church Cathedral relies on natural ventilation by way of six (6) operable windows in the clerestory walls of the Nave, shown in Figure 73, and the natural infiltration, exfiltration, and breathability of the building envelope. There is a hatch leading upwards into the steeple that would have been used for summer ventilation, creating a chimney effect, however it is unknown if this is still used. The Cathedral has no mechanical ventilation, humidification, or dehumidification systems and, from observation (alone), the building likely does not require complex systems. There are three (3) small destratification fans in upper reaches of the Nave and Chancel, however these were observed to be small commercial fans and ineffective in achieving the goal of air movement within the spaces. There are also four (4) basement vent openings in the foundation (Figure 74) to provide ventilation to and from the basement. From observation these openings may be blanked off to some extent with pressure treated plywood.

Figure 74: Basement vent opening

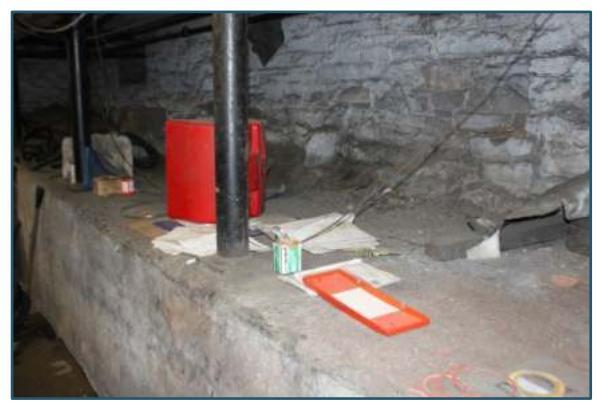
It was also observed that the basement has become a cluttered space with debris, parts, appliances, trash, wood, pipe, hose, and general items stored in basement haphazardly.

There are a number of concerns in this regard. The basement is a low ceilinged, cramped, and constrained space housing the building's heating system, fire protection equipment, electric equipment, and communications gear. There is a safety concern related to trips and falls hazards due to the amount items in the basement blocking pathways of ingress and egress. Further, the building systems equipment crowding is exacerbated by the storage and debris (Figure 75 right and Figure 76). Another observance is of boiler documents left on the foundation next to the boiler (Figure 75 left). The concern is an absence of a central location and completeness of Operations & Maintenance Manuals and materials. A last maintenance concern is the potential that only one person has systems operation experience, history, and knowledge. If that one person becomes unavailable in the event that they are needed, the Cathedral would be in the poor position of having few operational options.

Figure 75: Boiler Documents (left) and debris (right)

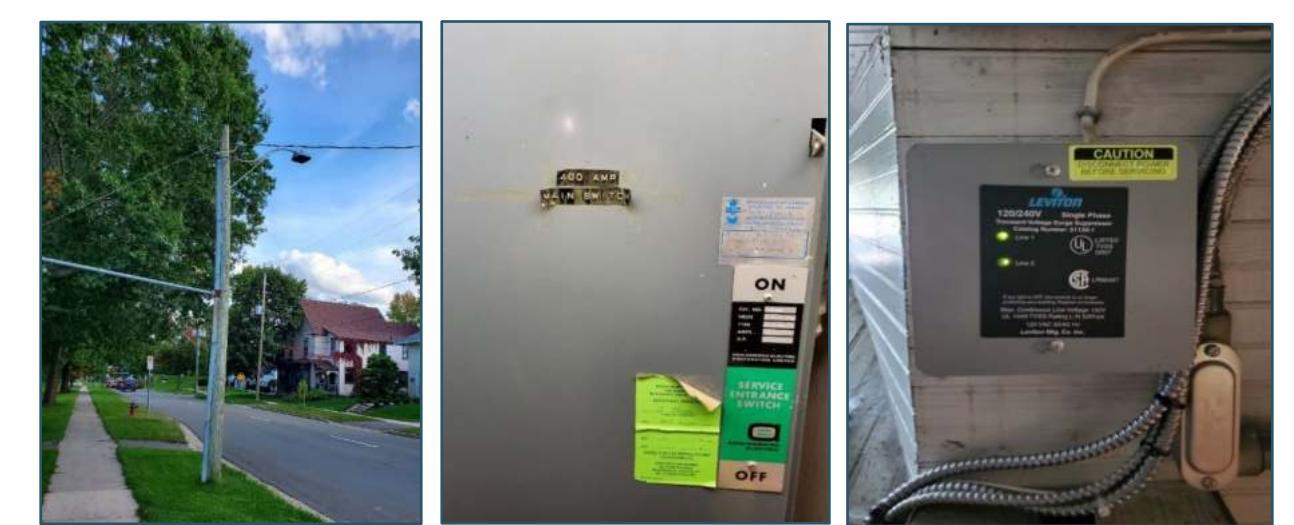
The electrical service to Christ Church Cathedral is a 400A, 120/240V, 1PH, 3W service, which is fed from the overhead secondary line across Brunswick Street to a lighting pole on the Cathedral side of the street (Figure 77). At the lighting pole, the secondary line enters conduit and is routed underground into the basement electrical room. Once in the electrical room, the service goes through a 400A disconnect switch followed by a metering cabinet. After the metering cabinet, the service arrives at a splitter which acts as the distribution hub. Fed from the splitter is a 200A disconnect with 200A fuses which feeds the lighting panel located behind the curtain in the Lady Chapel. Exterior building flood lights are the next feed off the splitter and go through a small disconnect switch. Another feed taken from the splitter is a 200A disconnect switch feeding the boiler panel. The boiler panel has single phase surge protection which appears to be connected and working (Figure 79). This provides much needed protection to the building's electrical distribution system. As can observed in Figure 81, there are additional feeds coming from the distribution splitter; however, due to the disorderly (idiosyncratic/irregular) arrangement and questionable (uncertain/vague) labelling practices, it is difficult to determine what is connected. The various pieces of electrical equipment in the building appears to have been installed at different times and has had upgrades and/or been repaired on an as needed basis. As a result, a large portion of the electrical work is disordered, vague, unorganized, and difficult to trace. For example, an existing fire alarm panel which appears to no longer be connected is still installed on the wall with various cables entering its enclosure.

*Figure 77: Incoming service overhead to underground*

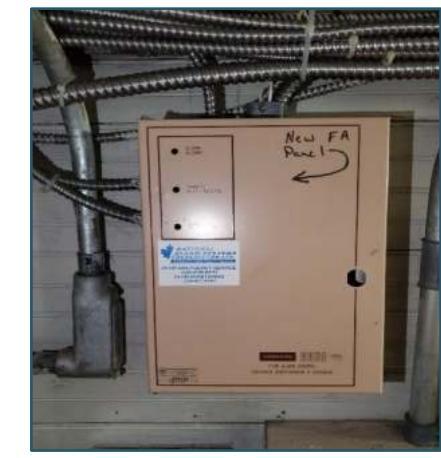
*Figure 80: Detached fire alarm panel*

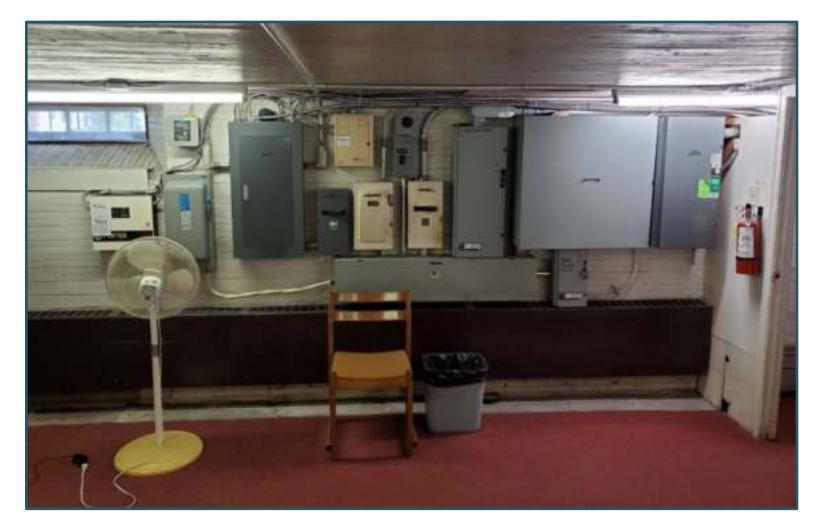
The current location of electrical service equipment does not meet code requirements for ceiling height. This means that if any of that gear were to be upgraded or replaced it would have to be moved to another location within the Cathedral unless the provincial electrical inspector decides to provide a deviance (variance) based on the historical significance of the Cathedral.

There is a large (hydronic) heater located directly below the electrical service entrance and distribution gear which can lead to overheating and premature electrical equipment failure.

*Figure 81: Electrical service / distribution equipment*

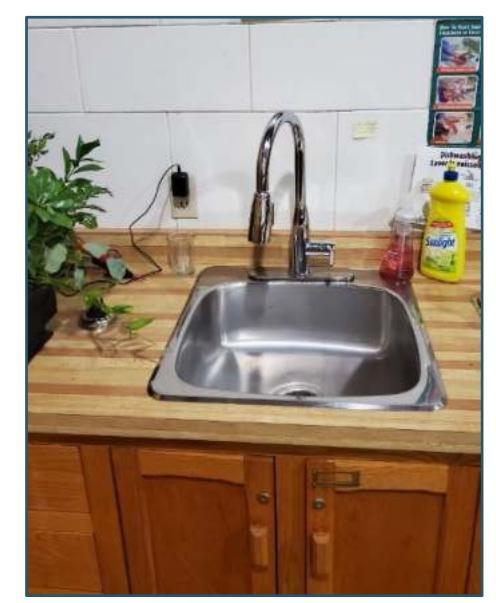
*Figure 82: Non-GFI receptacle*

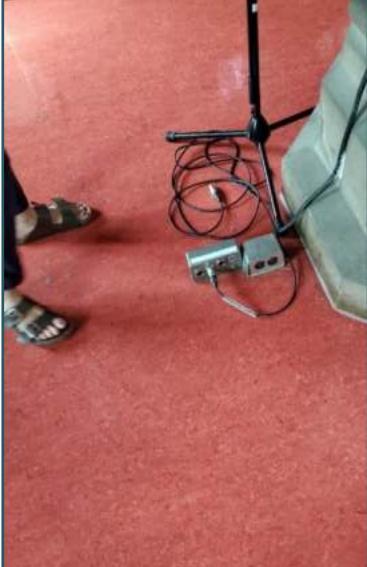
For the most part throughout the Cathedral, the number of available receptacles and their placement is not sufficient. The number of devices plugged into various power bars from single receptacles is an unsafe condition in terms of fire hazard and potential current code violation depending on the electrical loads. In the Clergy Vestry and Sacristy room, the receptacle behind the sink is not GFI (Figure 82). This is a code violation if the circuit is not protected by a GFI breaker. Floor boxes throughout the Nave are neatly and properly secured to the floor (Figure 83); however, the receptacle box by the

*Figure 83: Floor box receptacle*

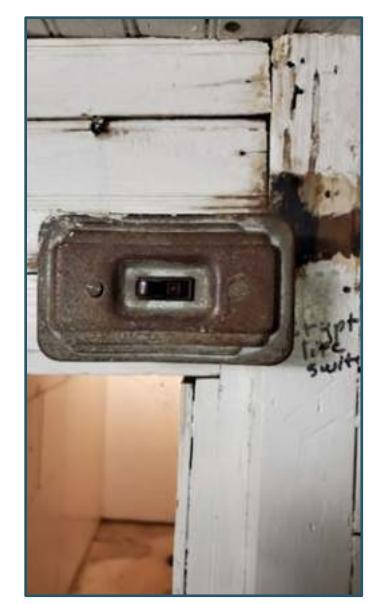
*Figure 84: Old surface mounted light switch*

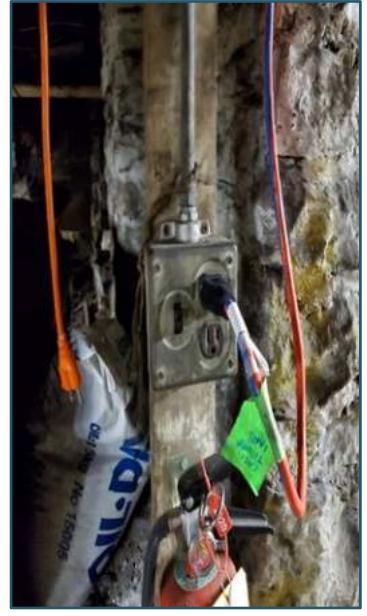
computer station is a code violation as it is not in a floor box and the armored cable is not protected which could lead to accidental mechanical damage to the feed. Many of the light switches and receptacles are nearing the end of their safe and useful life expectancy (for example Figure 85), which is approximately 30 years.

*Figure 85: Switch / receptable in basement*

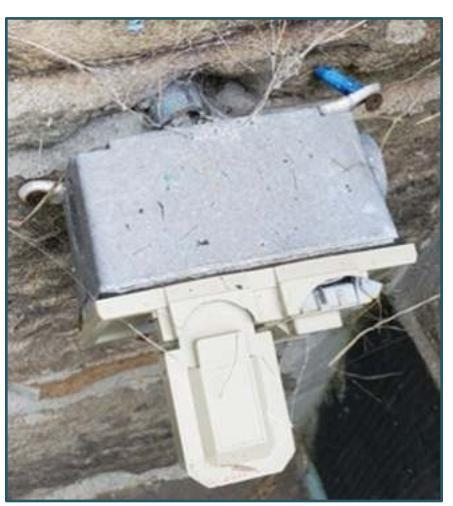
During the exterior building walk-around, it was observed that on each side there were copper conductors (likely to be ground wires), shown in Figure 89, that had been cut near the base of the building up to about 2 meters. These grounding wires appear to be connected to the Cathedral's lightning protection air terminals, Figure 90. This condition leaves the building at a severe risk to fire, or serious damage associated with a lightning strike. An exterior receptacle near the side door has begun to pull off the building, as shown in Figure 86, which will eventually lead to exposed wires and a safety hazard.

*Figure 86: Damaged exterior receptacle box*

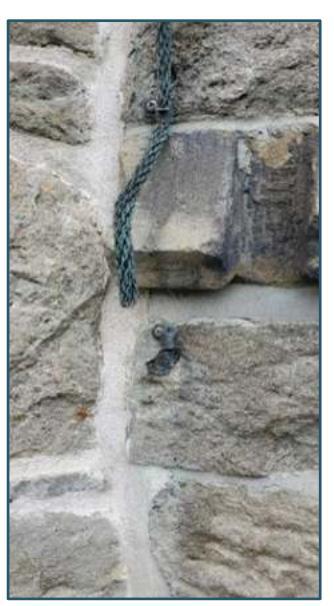
*Figure 89: Damaged lightning protection cable*

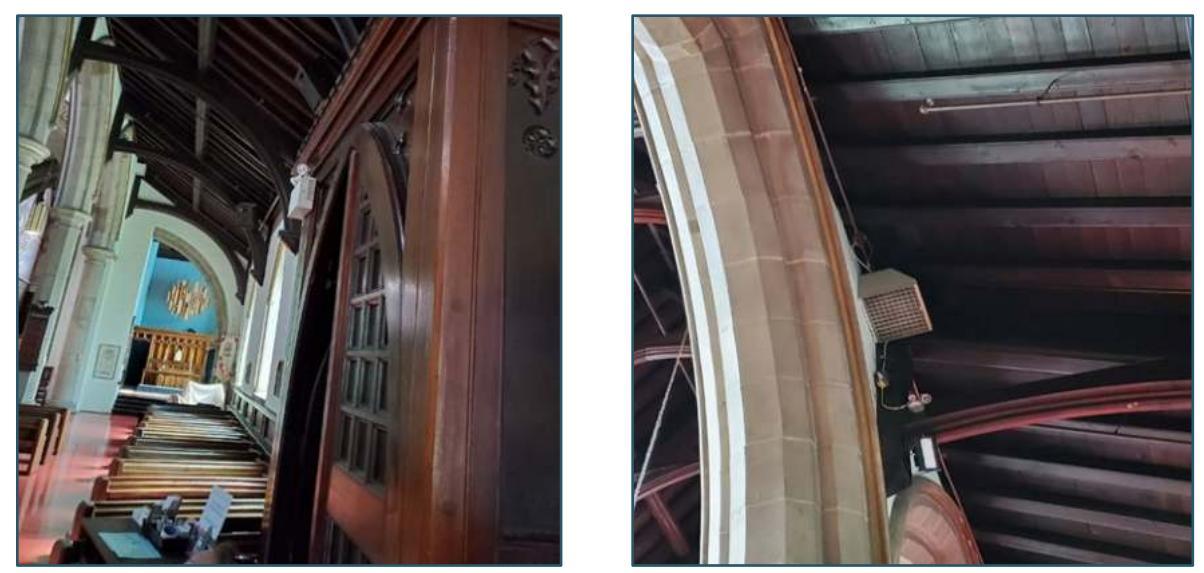
The Cathedral does have some emergency lights, shown in Figure 95, but likely not enough to meet the minimum light levels for egress during an emergency. Also, there are no exit lights installed anywhere in the Cathedral. Consideration in design will need to ensure lighting does not interfere with special services. For exterior lights on the building there are some wall sconce fixtures by the doors and there are a few high-pressure sodium flood lights on the roof (Figure 96, left).

*Figure 95: Emergency light with battery unit (left) and remote head emergency light (right)*

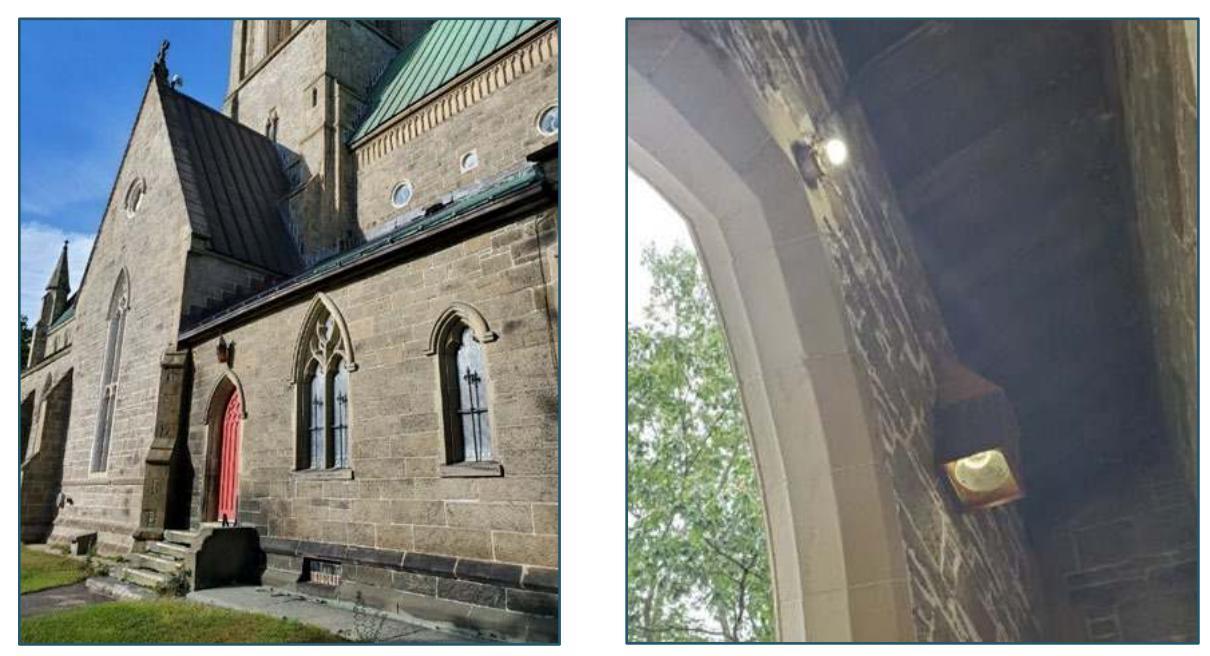
Figure 96: Exterior lighting at Choir door (left) and main front door lighting (right)

For the exterior of the building, the existing lighting presents as high-pressure sodium and is recommended to be replaced with exterior LED lighting. The existing perimeter lighting is orange in colour indicative of high-pressure sodium - this equipment is energy efficient but has little colour rendering. The replacement option would be an LED type of fixture, which would provide a 'whiter' light with improved colour rendering.

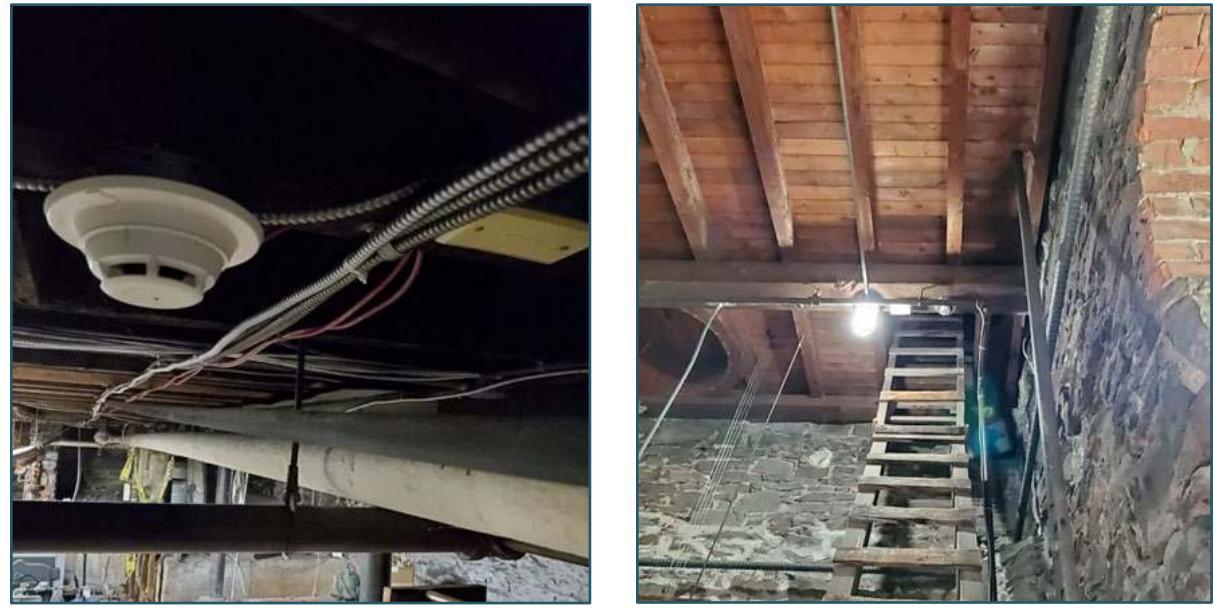
Christ Church Cathedral is primarily protected by a sprinkler system with a few smoke detectors throughout the building (Figure 100). The primary issue observed in the Cathedral regarding the fire alarm system is that only two exits have pull stations present and one of those pull stations is taped over, shown in Figure 101 and Figure 102. All building exits and exits from floor levels must be equipped with a fire alarm pull station. An audible alert for a fire alarm is generated by bells, which is a good device for the space; however, only two bells are in the main space, and they are both in the Lady Chapel which likely will not produce the required 65dBA at the rear of the Nave (Figure 103). Audibility is required throughout all occupied spaces of the building which is not possible with the existing system configuration.

Figure 100: Basement smoke detector (left) and tower smoke detector (right)

Since the building is complete with a sprinkler system, the only requirement for detection devices is to be at the top of each stairway. It is recommended that all heat detectors throughout the building are removed and the smoke detectors at the top pf each stairwell be replaced complete with new wiring. It is also recommended that all manual pull stations be replaced and mounted to meet accessibility standards. New pull stations are also recommended to be installed in the Choir and Clergy Vestry rooms as there are exits from the building from those rooms that currently do not have pull stations. Pull stations should also be added within the bell tower and at the bottom of the stairwell to basement.

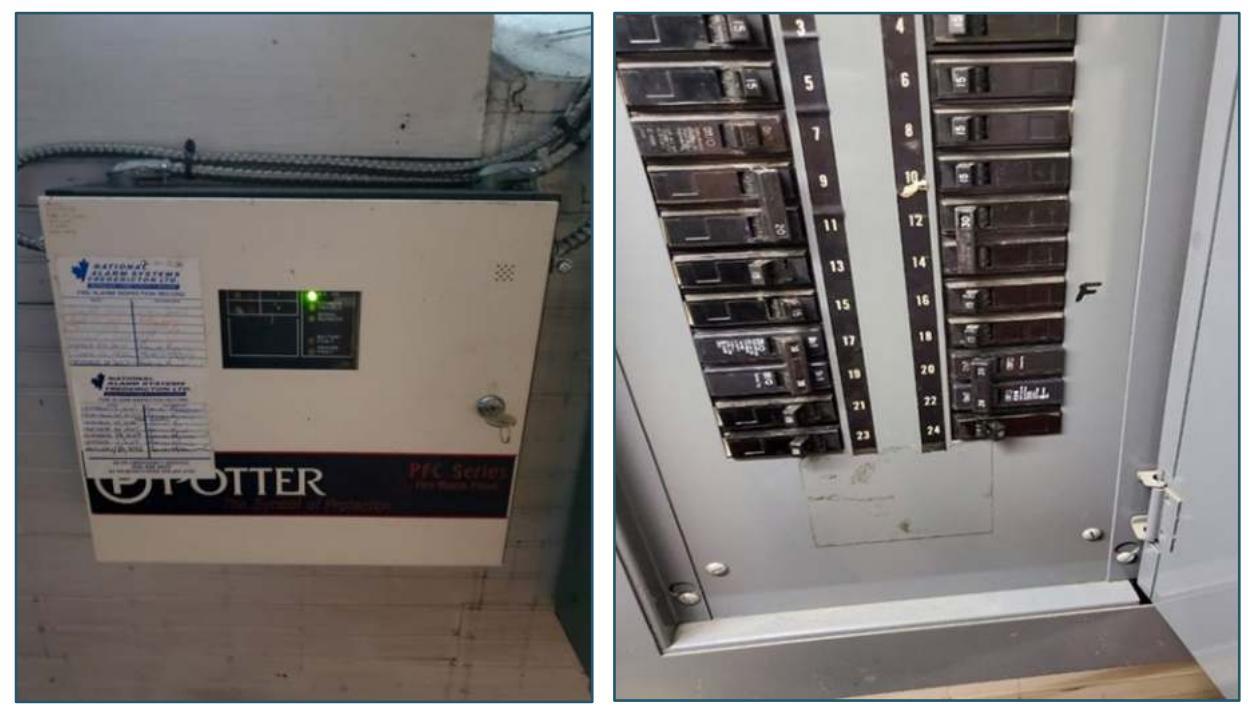
The fire alarm control panel (Figure 104) is in the electrical room and is the only annunciator in the building. Not having an annunciator at one of the main entrances is a code violation that should be addressed. The system is a Potter PFC Series and appears to be working correctly as it was inspected January 20th, 2021, by National Alarm Systems Fredericton LTD. The circuit breaker feeding the fire alarm panel is missing a locking device to prevent it from being accidentally turned off, shown in Figure 105.

Figure 104: Fire alarm panel

Figure 105: Fire alarm panel with no lock device

The fire alarm control panel is located within the electrical room which is not near the main entrance. The Fire Marshall typically requires the control panel or an annunciator panel to be located near the entrance in which the fire department would enter. With the age of the system, it is recommended that the panel be replaced, and a new panel be installed in the main entrance vestibule or just inside the main doors if the vestibule doesn't provide a suitable installation location.

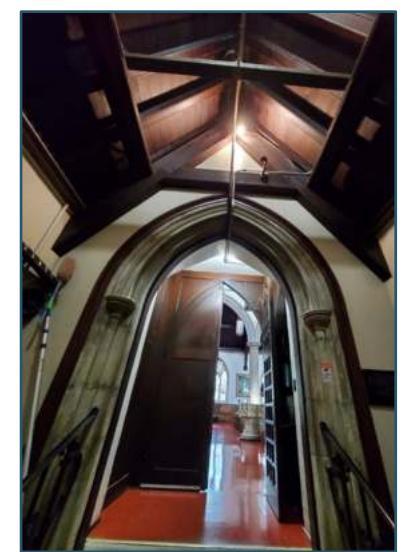
*Figure 106: South side entrance security camera*

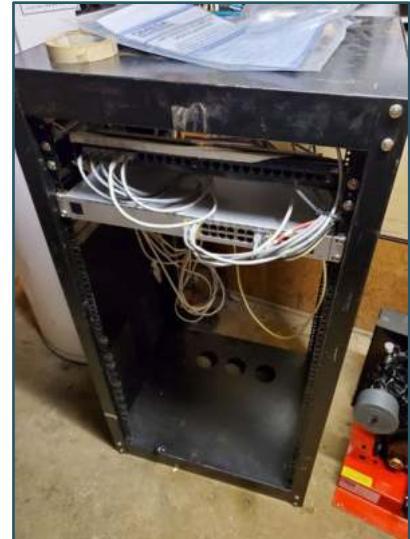
Figure 107: Security system rack

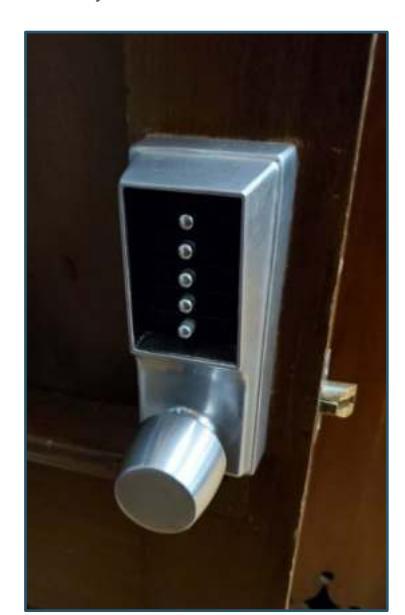
Figure 109: Rear door lock

Two rear doors to the Choir Vestry and Clergy Vestry rooms have local integrated keypad door locks installed. These door locks are in good condition and do not need to be upgraded unless additional monitoring of the doors is requested. The CCTV cameras appear to be in fair condition and are installed in key locations. If the Cathedral is satisfied with the quality of video capture and video capture storage capabilities of the system, the system can remain in service without need to upgrade. It is

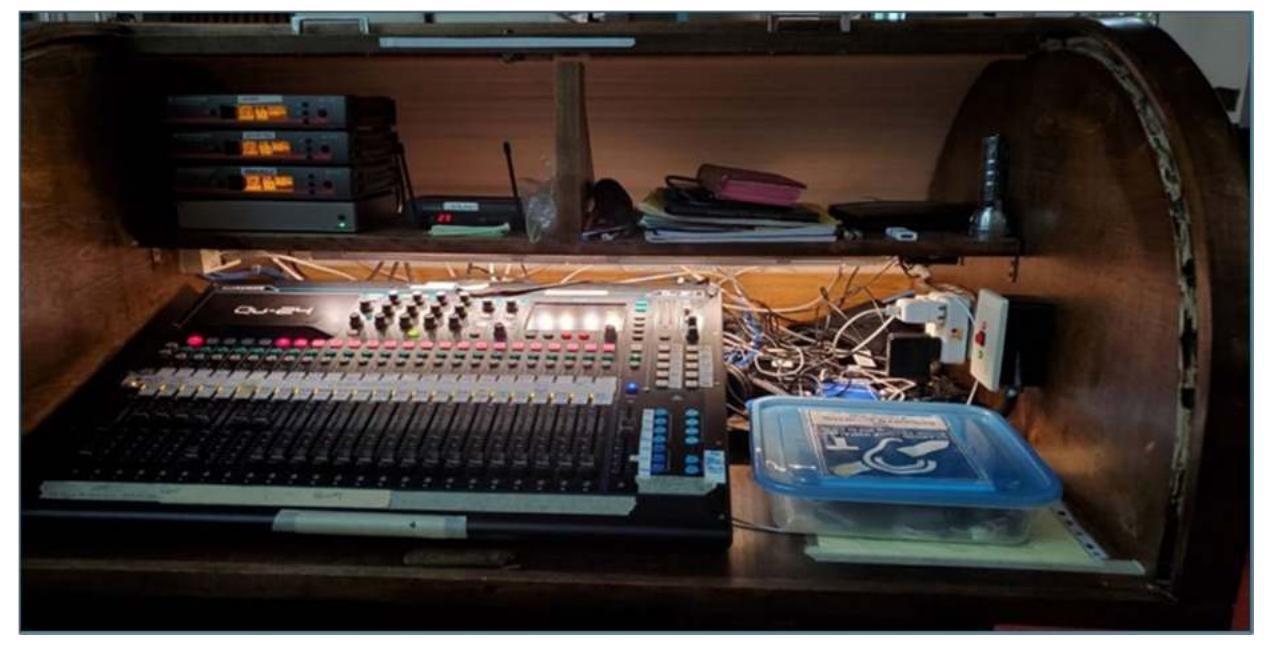
Figure 112: Sound system controls

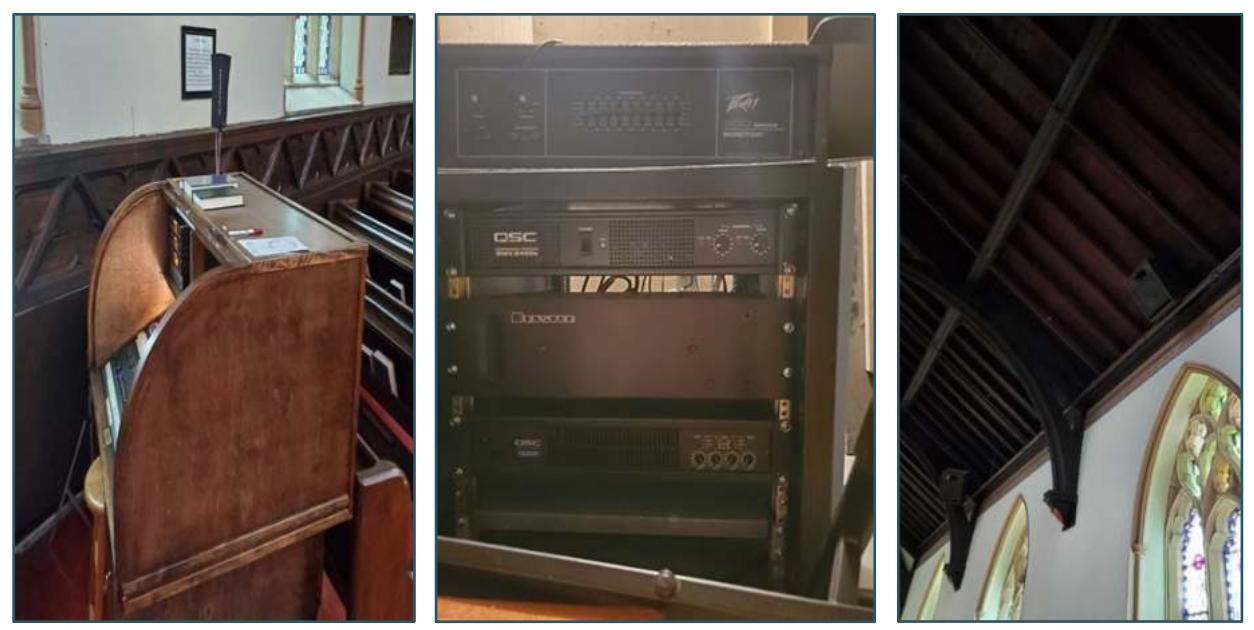
Figure 113: Audio booth

located in the sound booth is running off one power bar which, depending on the ratings of the equipment, is likely a code violation and fire hazard.

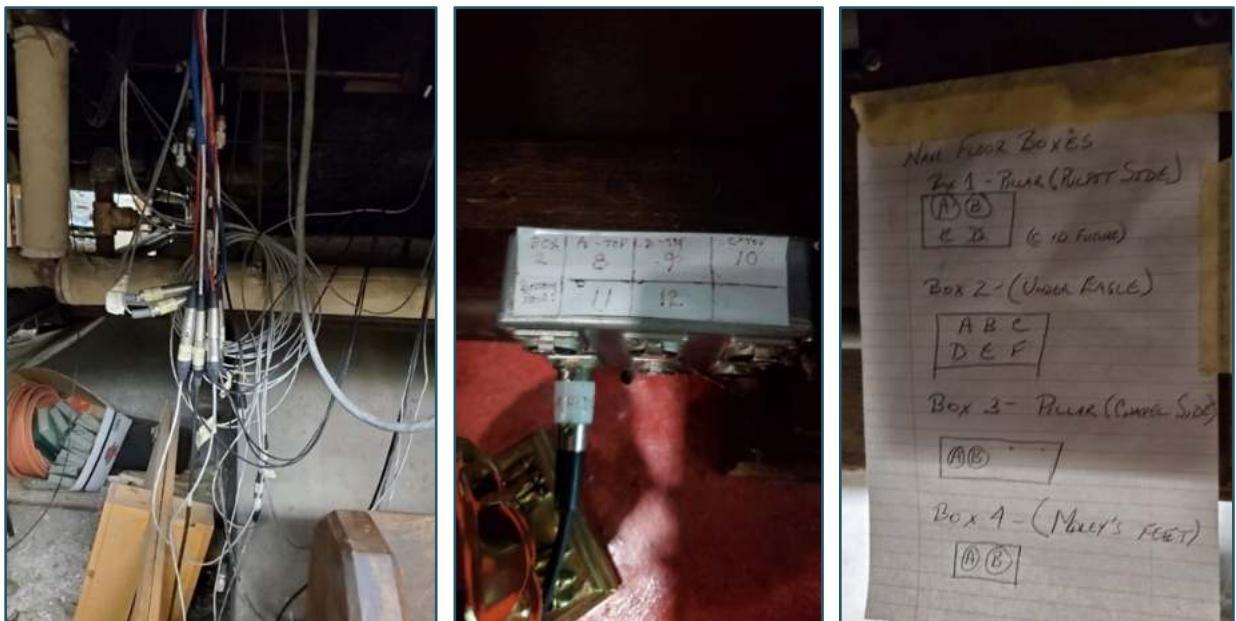
Another observation is that the audio cables in the basement that are connected to floor boxes throughout the main area (Figure 116) are free hanging. These cables should be supported by j-hooks or run within conduit to prevent inadvertent damage to these cables. Cables should be carefully labeled which most appeared to be (Figure 117 and Figure 118).

*Figure 116: Basement audio cables*

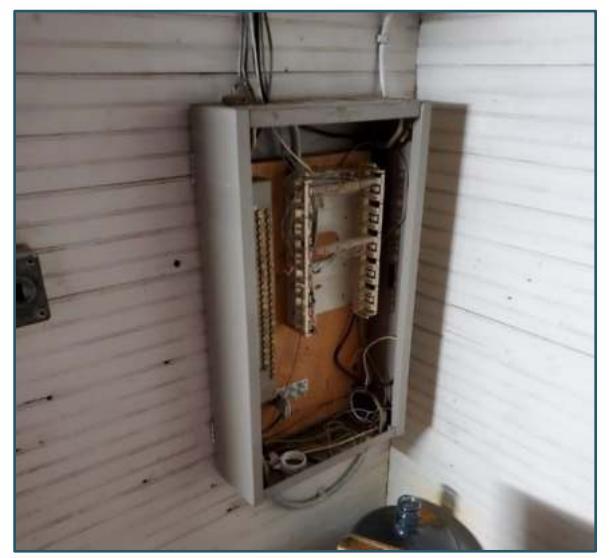
The communication service comes into the Cathedral and is terminated in a BIX panel, shown in Figure 119, which is in the basement, in the same room where the electrical equipment is located. Throughout the Cathedral there are a few telephone jacks with phones connected to them (Figure 120) and the computer and sound booth stations are complete with network cables. In the basement where the security panel is located, the communication wiring appears to be labeled but most of the infrastructure is dated and is another viable candidate for upgrade.

Figure 119: BIX panel
