# Christ Church Cathedral Building Conditions and Issues Report

Project 21272

**Revision 0**

HERITAGE STANDING INC.

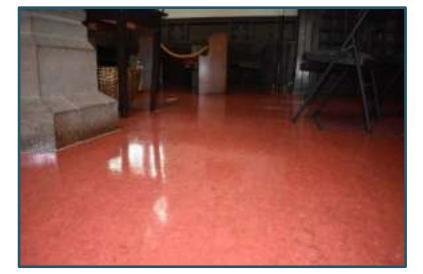
The flooring was sheet or rolled flooring (Figure 134) with welded seams glued to what appeared to be a second plywood sub-floor on top of the original sub-floor (Figure 135). The narrow strip of flooring behind the effigy of Bishop Medley was the only section found that had lifted, allowing the plywood subfloor to be visible. The flooring is sealed around the edges of columns and other permanent elements. Generally, the flooring was in good condition. There were no readily visible points where the flooring was torn, worn through, or where there were large cuts. Some of the welded seams are separating (Figure 136) and the flooring is scuffed in front of pews and a few other areas (Figure 137).

*Figure 134: General view of flooring*

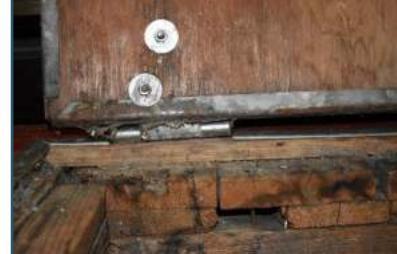
*Figure 135: Visible floor layers at basement trap door*

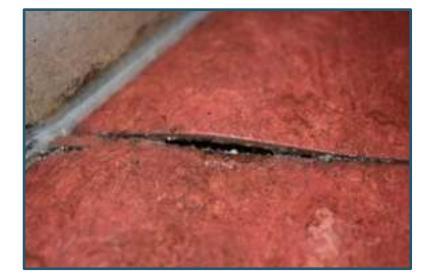
*Figure 136: Failed welded seam at base of column*

A review of photos indicates that the flooring was installed after 1983, and a review of written documentation suggests it may have been installed in the 1990s. The life expectancy of commercial sheet flooring is approximately 30 years. With the light use of a church setting, this could be longer.

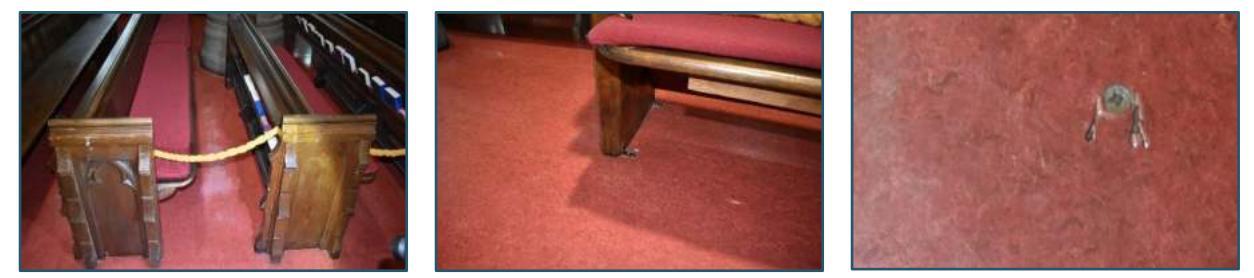
Pews were attached to the floor with the use of steel angle braces and screws into the floor and the pews (Figure 138 and Figure 139). The size of the screw heads was approximately 0.25 inches in diameter. The length of the screws is unknown. No screws were visible extending from the original sub-floor from the vantage point of the basement. Where pews had been removed, the screws had been countersunk in place (Figure 138 and Figure 139). At these points, the flooring was in good condition. It appears that the screws had not caused tearing or cracking, although at times the brackets made deep impressions or small cuts into the flooring.

*Figure 137: Scuffed area in front of a pew*

*Figure 138: Angle brace and screws attaching pew to floor*

*Figure 139: Countersunk screw remaining after pew removal*
